Express5800/R120h-1M (2nd-Gen), R120h-2M (2nd-Gen) ご使用時の注意事項

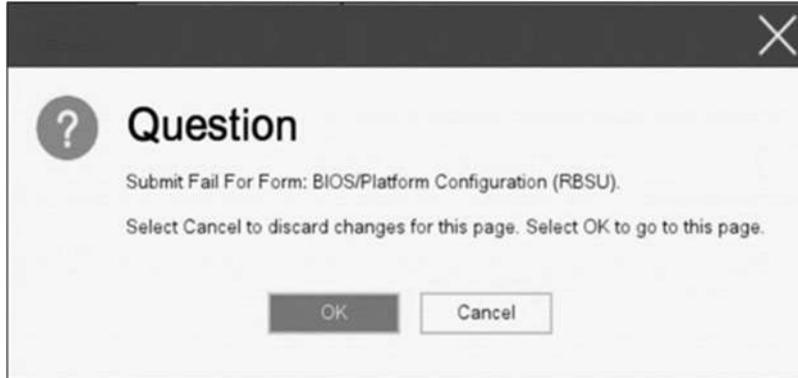
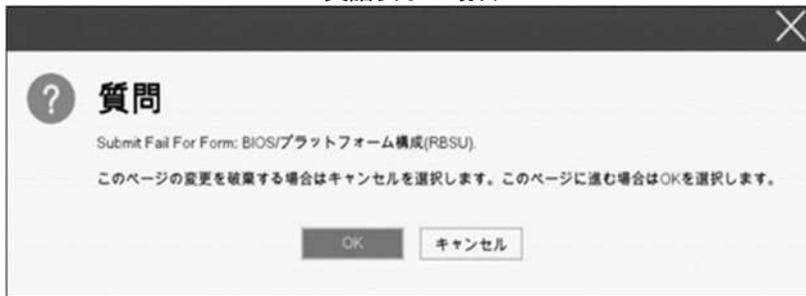
● Submit Fail For FormのQuestion(質問)ポップアップ表示についての注意事項

さらに、サーバーの再起動を行ってシステムユーティリティに入りなおしてから設定の変更を再度行ってください。もし「OK」を押してそのまま設定変更を進めると、装置に記録されているSerial Number、Product IDなどの設定情報を消失することがあります。

システムユーティリティにおいて設定の変更中に、次のSubmit Fail For FormのQuestion(質問)ポップアップが表示された場合は、「キャンセル」を選択して変更を破棄してください。

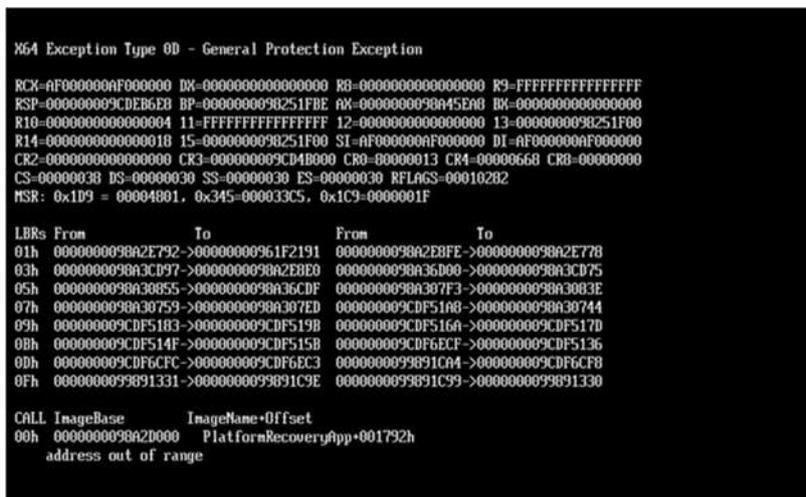
赤文字画面の例

装置の構成変更や設定変更などシステムの状態を変更した場合や、接続デバイスへのアクセスタイミングにより、OS起動前に稀に赤文字画面(RSOD)が表示され、本製品の操作が出来なくなることがあります。構成変更や設定変更に伴う一過性の事象の場合があり電源OFF/ONによって回復します。

赤文字画面(RSOD)が表示された場合、装置の電源OFF/ONをお願いします。

問題が解決しないときは、保守サービス会社にお問い合わせください。

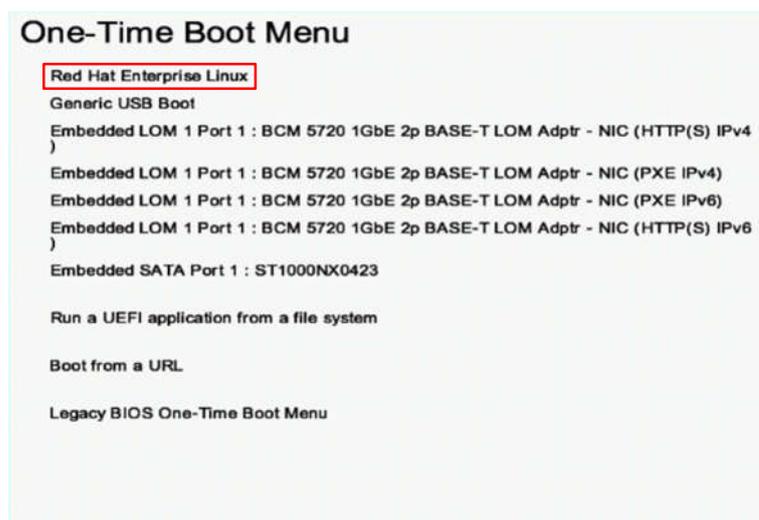
ワンタイムブートメニュー画面

OSがインストールされたHDDやSSDなどのブートデバイスを選択した場合、Red Screen of Death (RSoD)が発生することがあります。

ワンタイムブートメニューから起動する場合、OSブートマネージャー(例: Red Hat Enterprise Linux)を選択してください。

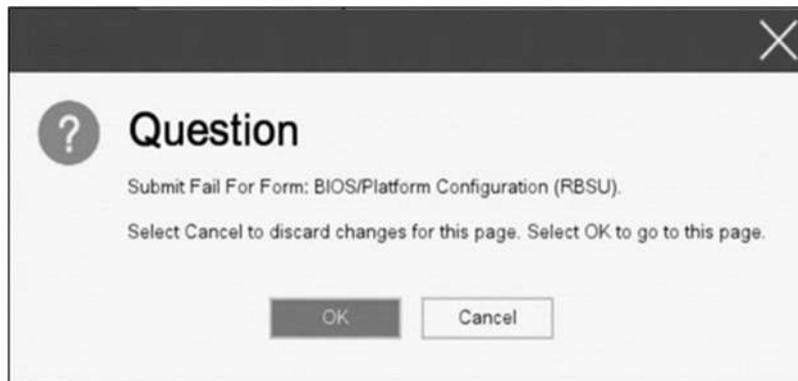
• Caution for the “Submit Fail For Form” Question pop-up

If you encounter the “Submit Fail For Form” Question pop-up while changing the configuration in the System Utilities, **discard the changes by pressing Cancel**. To apply the desired changes after that, reboot the server and re-enter the System Utilities. Selecting OK to continue the changes may cause some server settings such as Serial Number and Product ID to be lost.

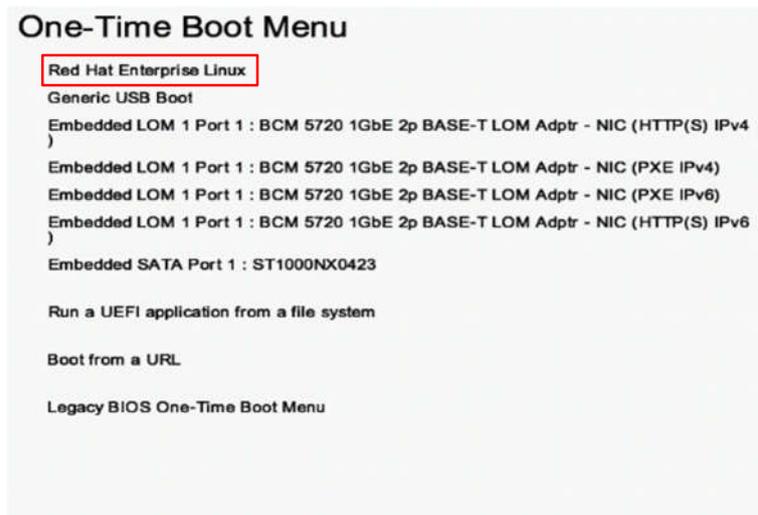
One-Time Boot Screen

Select "OS Boot Manager" when booting OS from "One-Time Boot Menu".
Selecting an OS boot device such as HDD/SSD on the "One-Time Boot Menu" may cause RSoD (Red Screen of Death).

- **Cautions on using Red Hat Enterprise Linux 8.5 or earlier**
