Express5800/R120h-1M, R120h-2M

ご使用時の注意事項

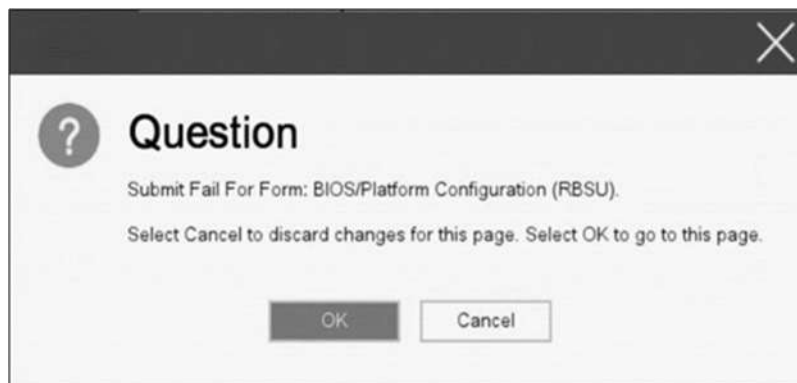
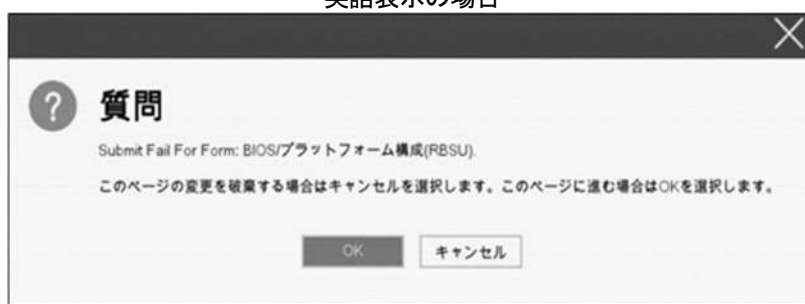
● Submit Fail For FormのQuestion(質問)ポップアップ表示についての注意事項

システムユーティリティにおいて設定の変更中に、次のSubmit Fail For FormのQuestion(質問)ポップアップが表示された場合は、「キャンセル」を選択して変更を破棄してください。

さらに、サーバーの再起動を行ってシステムユーティリティに入りなおしてから設定の変更を再度行ってください。もし「OK」を押してそのまま設定変更を進めると、装置に記録されているSerial Number、Product IDなどの設定情報を消失することがあります。

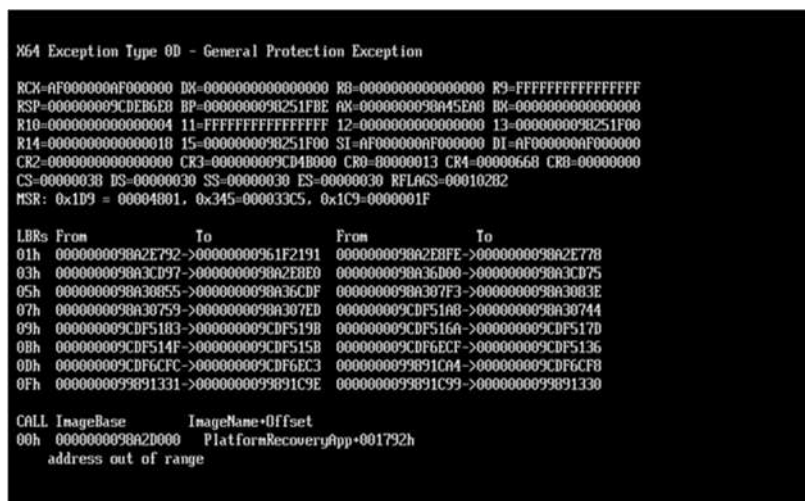
赤文字画面の例

● 赤文字画面(RSOD: Red Screen of Death)が表示された場合の対処について

装置の構成変更や設定変更などシステムの状態を変更した場合や、接続デバイスへのアクセスタイミングにより、OS起動前に稀に赤文字画面(RSOD)が表示され、本製品の操作が出来なくなることがあります。構成変更や設定変更に伴う一過性の事象の場合があり電源OFF/ONによって回復します。

赤文字画面(RSOD)が表示された場合、装置の電源OFF/ONをお願いします。

問題が解決しないときは、保守サービス会社にお問い合わせください。

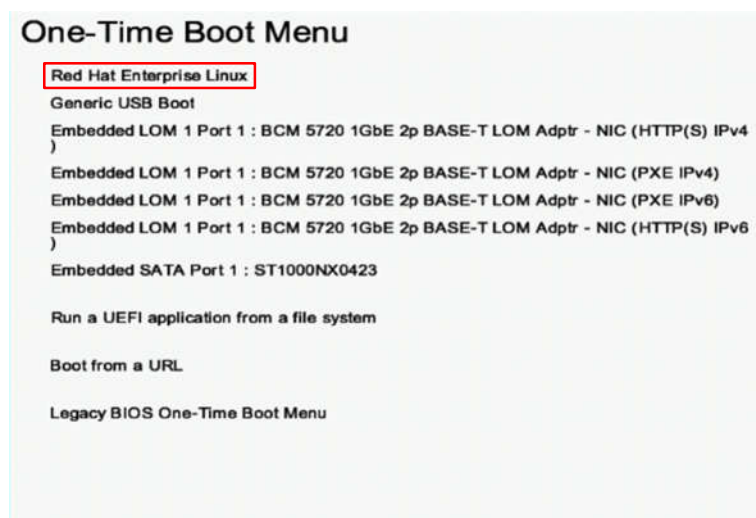
ワンタイムブートメニュー画面

ワンタイムブートメニューから起動する場合、OSブートマネージャー(例: Red Hat Enterprise Linux)を選択してください。

OSがインストールされたHDDやSSDなどのブートデバイスを選択した場合、Red Screen of Death (RSoD) が発生することがあります。

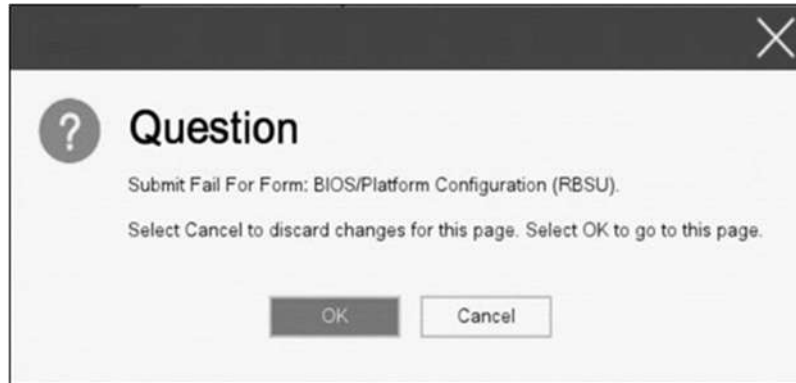
• Caution for the “Submit Fail For Form” Question pop-up

If you encounter the “Submit Fail For Form” Question pop-up while changing the configuration in the System Utilities, **discard the changes by pressing Cancel**. To apply the desired changes after that, reboot the server and re-enter the System Utilities. Selecting OK to continue the changes may cause some server settings such as Serial Number and Product ID to be lost.

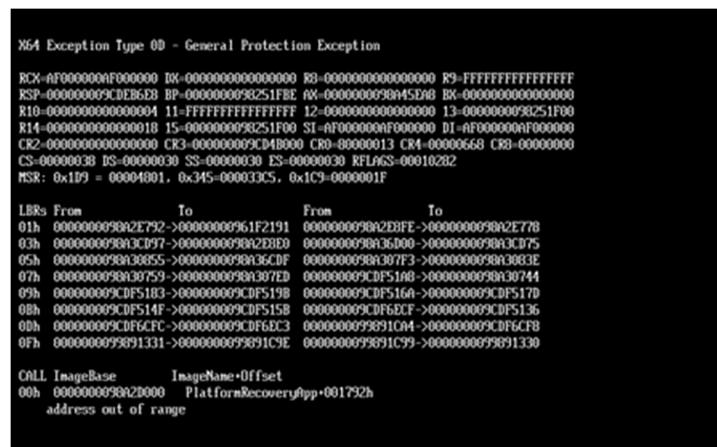
• Caution for recovering from a Red Screen of Death (RSOD) screen

If you have changed the server configuration/settings or the system status, a Red Screen of Death (RSOD) screen appears in rare cases before starting up the OS. This may cause the server to become uncontrollable. However, the server may recover from the RSOD by turning off and then on the power again.

To recover from this condition, power off and then on the server again.

If the problem persists, contact your sales representative for maintenance.

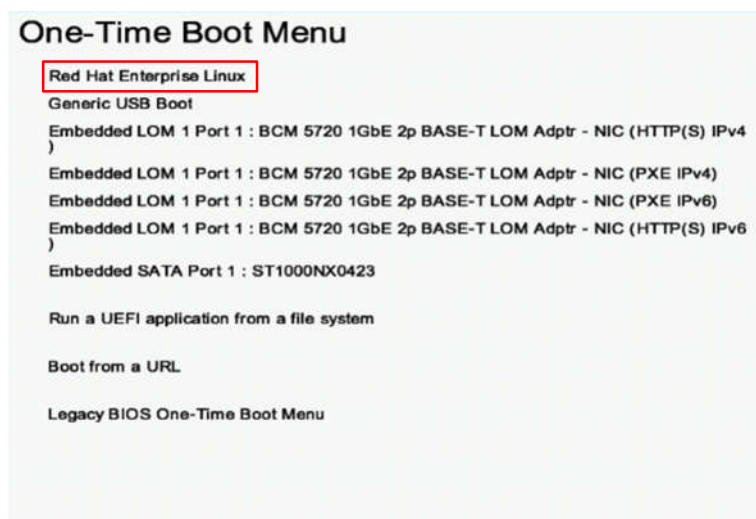
One-Time Boot Screen

Select "OS Boot Manager" when booting OS from "One-Time Boot Menu".

Selecting an OS boot device such as HDD/SSD on the "One-Time Boot Menu" may cause RSoD (Red Screen of Death).
