# Express5800/R120h-1M (3rd-Gen), R120h-2M (3rd-Gen)

## ご使用時の注意事項

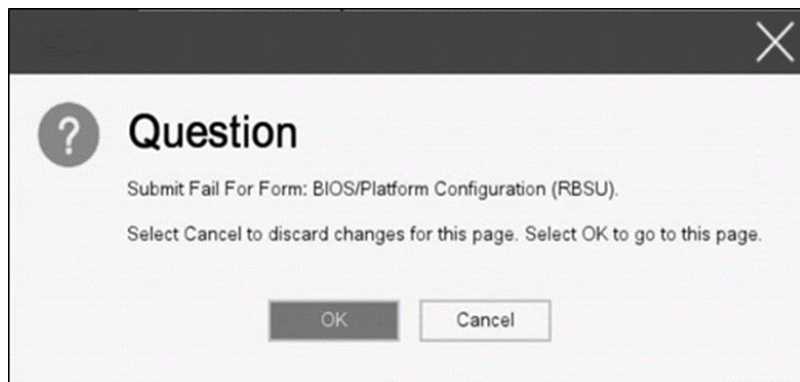
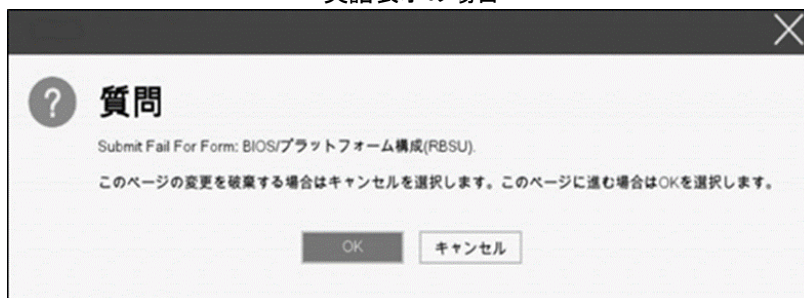
### ● Submit Fail For FormのQuestion(質問)ポップアップ表示についての注意事項

システムユーティリティにおいて設定の変更中に、次のSubmit Fail For FormのQuestion(質問)ポップアップが表示された場合は、「キャンセル」を選択して変更を破棄してください。

さらに、サーバーの再起動を行ってシステムユーティリティに入りなおしてから設定の変更を再度行ってください。もし「OK」を押してそのまま設定変更を進めると、装置に記録されているSerial Number、Product IDなどの設定情報を消失することがあります。

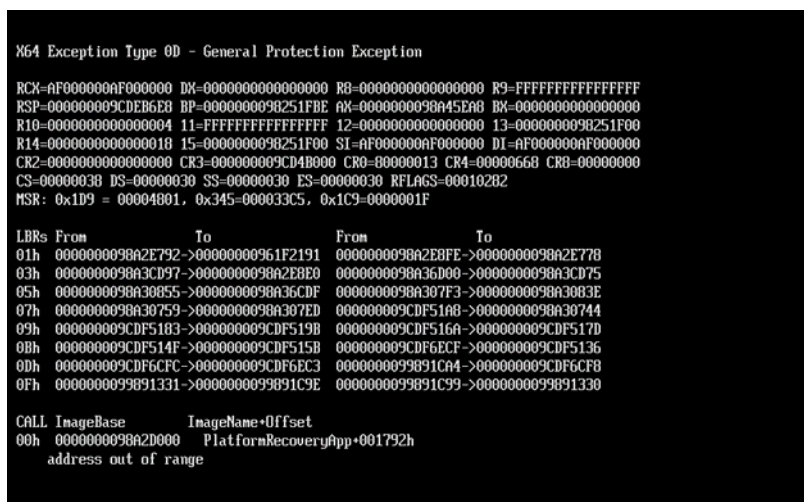
赤文字画面の例

### ● 赤文字画面 (RSOD : Red Screen of Death)が表示された場合の対処について

装置の構成変更や設定変更などシステムの状態を変更した場合や、接続デバイスへのアクセスタイミングにより、OS起動前に稀に赤文字画面 (RSOD)が表示され、本製品の操作が出来なくなることがあります。構成変更や設定変更に伴う一過性の事象の場合があり電源OFF/ONによって回復します。

赤文字画面 (RSOD)が表示された場合、装置の電源OFF/ONをお願いします。

問題が解決しないときは、保守サービス会社にお問い合わせください。

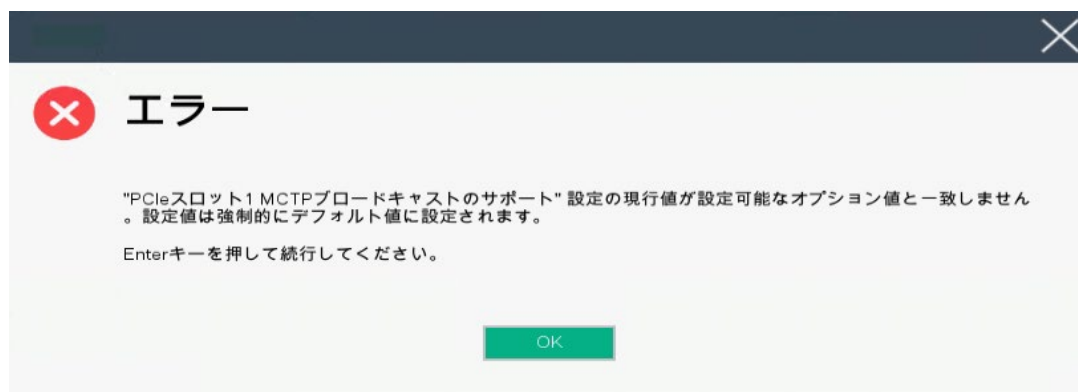
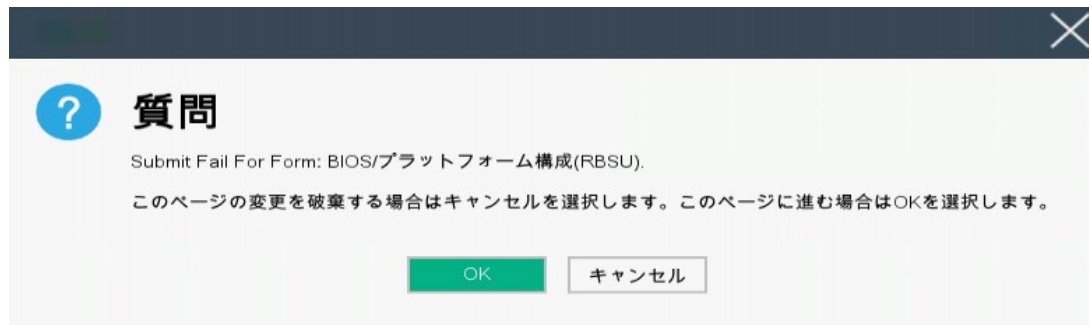
システム ROM v2.10 (05/21/2019) 以上の装置において、初めて PCIe MCTP Options メニュー(\*1)を選択した場合、装置のデフォルト設定を強制的に設定する旨のポップアップ(\*2)が、設定可能な PCIe Slot 数分表示されます。設定を一度保存すると、次回以降ポップアップ表示はされません。

なお、下記システム ROM バージョンの場合、設定保存時にポップアップ(\*3)が表示され設定は保存されません。保存されないことにより、本メニューを表示させるたびに PCIe Slot 数分のポップアップ(\*2)が表示されることになります。この場合、MCTP Broadcast は常に有効で動作します。

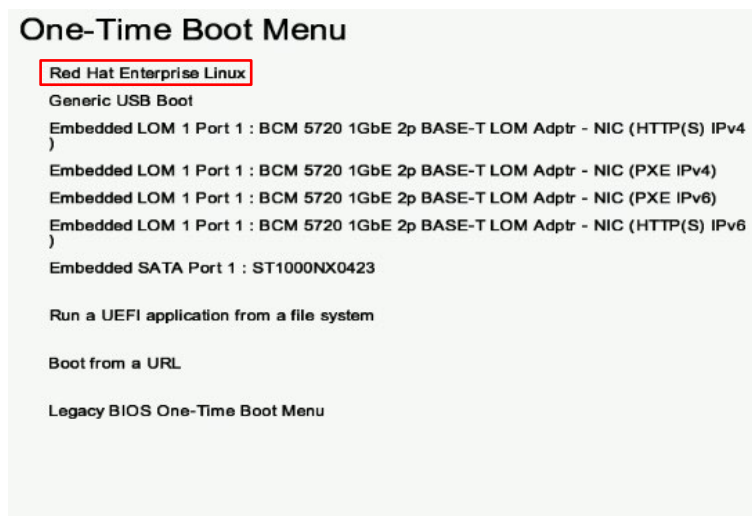
ワンタイムブートメニュー画面

OSがインストールされたHDDやSSDなどのブートデバイスを選択した場合、Red Screen of Death (RSoD)が発生することがあります。

ワンタイムブートメニューから起動する場合、OSブートマネージャー(例: Red Hat Enterprise Linux)を選択してください。

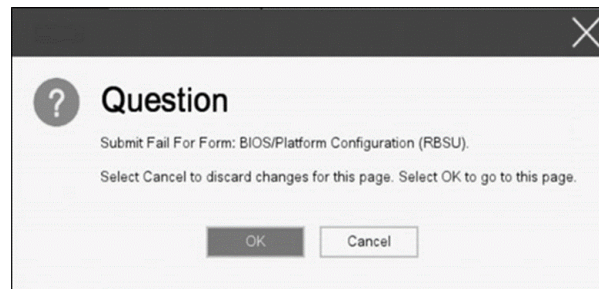
### • Caution for the “Submit Fail For Form” Question pop-up

If you encounter the “Submit Fail For Form” Question pop-up while changing the configuration in the System Utilities, **discard the changes by pressing Cancel**. To apply the desired changes after that, reboot the server and re-enter the System Utilities. Selecting OK to continue the changes may cause some server settings such as Serial Number and Product ID to be lost.

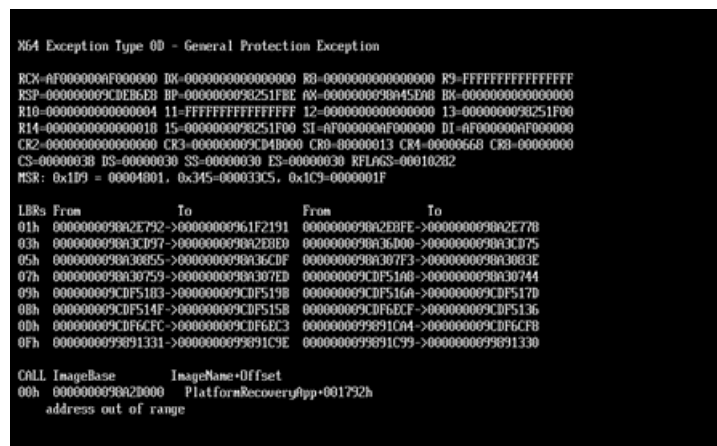
### • Caution for recovering from a Red Screen of Death (RSOD) screen

If you have changed the server configuration/settings or the system status, a Red Screen of Death (RSOD) screen appears in rare cases before starting up the OS. This may cause the server to become uncontrollable. However, the server may recover from the RSOD by turning off and then on the power again.

To recover from this condition, power off and then on the server again.

If the problem persists, contact your sales representative for maintenance.
