# Express5800/T120hご使用時の注意事項

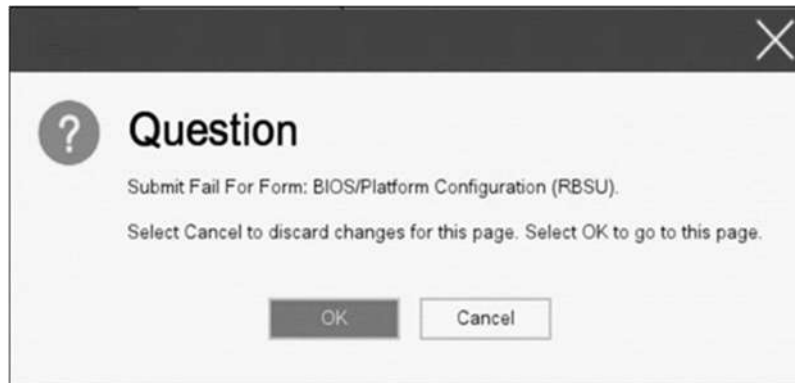
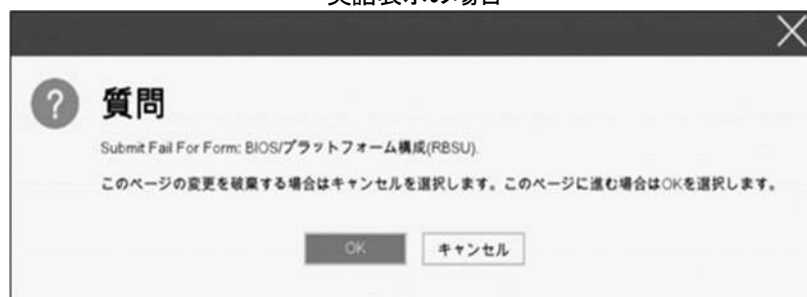
システムユーティリティにおいて設定の変更中に、次のSubmit Fail For FormのQuestion(質問)ポップアップが表示された場合は、「キャンセル」を選択して変更を破棄してください。

さらに、サーバーの再起動を行ってシステムユーティリティに入りなおしてから設定の変更を再度行ってください。もし「OK」を押してそのまま設定変更を進めると、装置に記録されているSerial Number、Product IDなどの設定情報を消失することがあります。

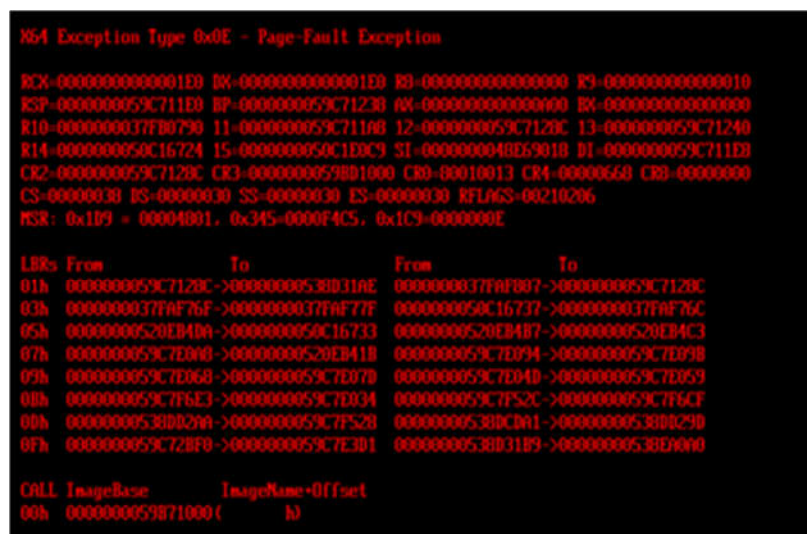
赤文字画面の例

装置の構成変更や設定変更などシステムの状態を変更した場合や、接続デバイスへのアクセスタイミングにより、OS起動前に稀に赤文字画面 (RSOD) が表示され、本製品の操作が出来なくなることがあります。構成変更や設定変更に伴う一過性の事象の場合があり電源OFF/ONによって回復します。

赤文字画面 (RSOD) が表示された場合、装置の電源OFF/ONをお願いします。

問題が解決しないときは、ファーストコンタクトセンターにお問い合わせください。

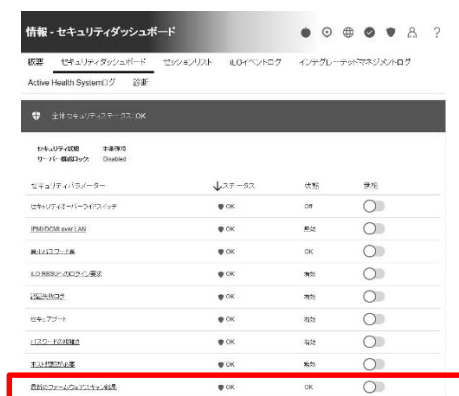
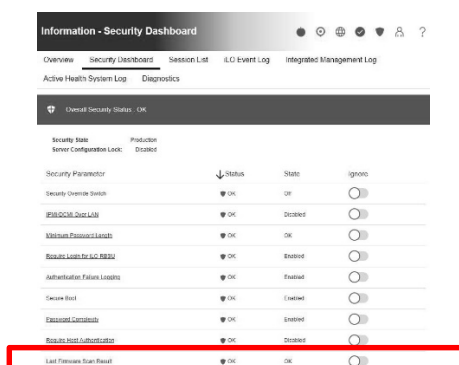
iLO 5ファームウェアバージョン1.43以上、2.10未満をご使用の場合、[Information] - [Security Dashboard]に [Last Firmware Scan Result]が表示されますが、本ハイパーリンクをクリックしないでください。

誤ってクリックした場合、Webサイト内のメニュー間移動が出来なくなります。その場合、ブラウザーのリロードボタンをクリックするか、もしくはいったんiLO Webインターフェースのログアウトを実行して再度ログインしてください。

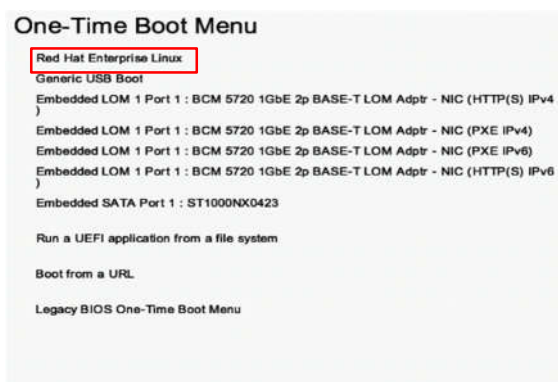
ワンタイムブートメニュー画面

OSがインストールされたHDDやSSDなどのブートデバイスを選択した場合、Red Screen of Death (RSoD)が発生することがあります。

ワンタイムブートメニューから起動する場合、OSブートマネージャー(例: Red Hat Enterprise Linux)を選択してください。

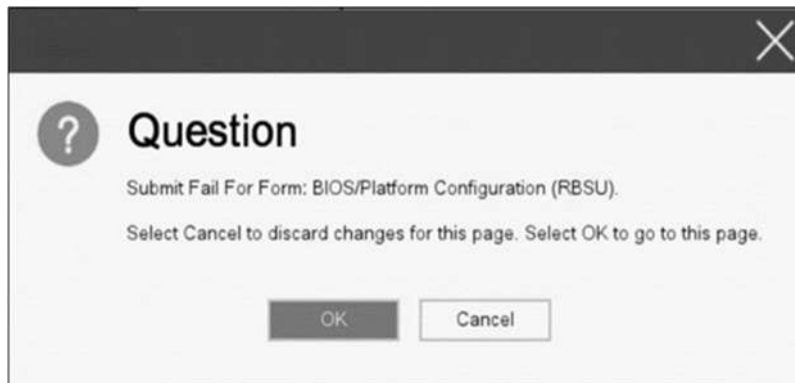
If you encounter the “Submit Fail For Form” Question pop-up while changing the configuration in the System Utilities, **discard the changes by pressing Cancel**. To apply the desired changes after that, reboot the server and re-enter the System Utilities. Selecting OK to continue the changes may cause some server settings such as Serial Number and Product ID to be lost.

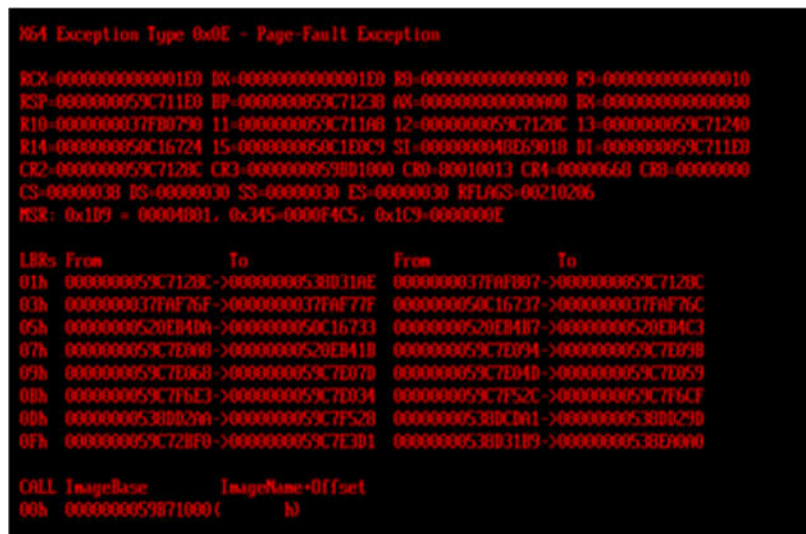
If you have changed the server configuration/settings or the system status, a Red Screen of Death (RSOD) screen appears in rare cases before starting up the OS. This may cause the server to become uncontrollable. However, the server may recover from the RSOD by turning off and then on the power again.

To recover from this condition, power off and then on the server again.

If the problem persists, contact your sales representative for maintenance.
