Express5800/R110j-1 ご使用時の注意事項

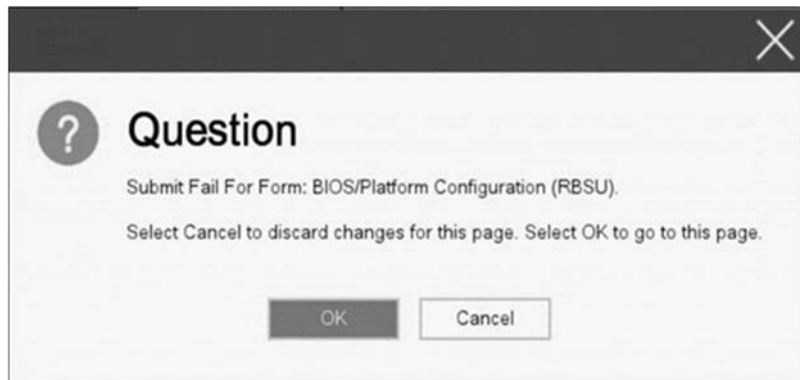
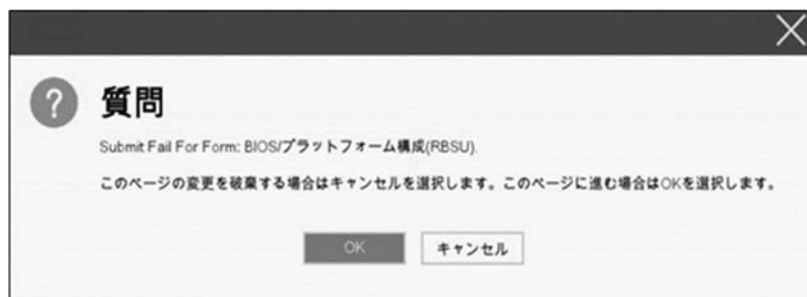
● Submit Fail For FormのQuestion(質問)ポップアップ表示についての注意事項

さらに、サーバーの再起動を行ってシステムユーティリティに入りなおしてから設定の変更を再度行ってください。もし「OK」を押してそのまま設定変更を進めると、装置に記録されているSerial Number、Product IDなどの設定情報を消失することがあります。

システムユーティリティにおいて設定の変更中に、次のSubmit Fail For FormのQuestion(質問)ポップアップが表示された場合は、「キャンセル」を選択して変更を破棄してください。

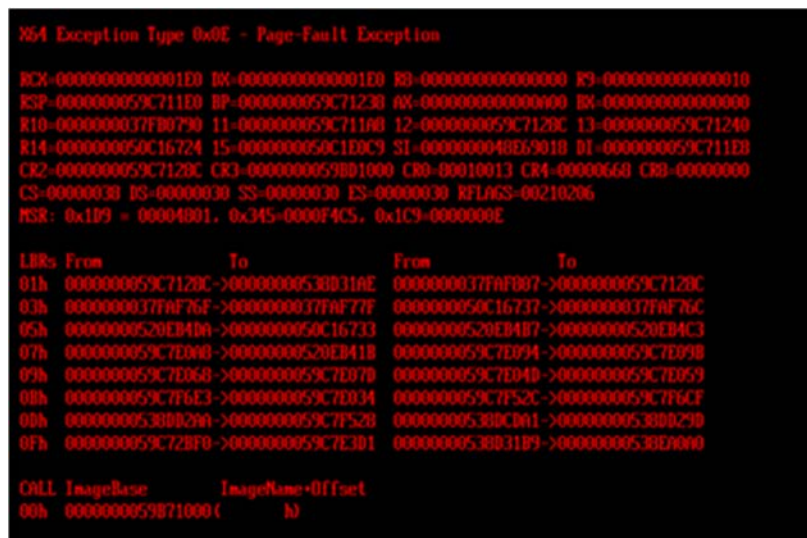
赤文字画面の例

装置の構成変更や設定変更などシステムの状態を変更した場合や、接続デバイスへのアクセスタイミングにより、OS起動前に稀に赤文字画面 (RSOD) が表示され、本製品の操作が出来なくなることがあります。構成変更や設定変更に伴う一過性の事象の場合があり電源OFF/ONによって回復します。

赤文字画面 (RSOD) が表示された場合、装置の電源OFF/ONをお願いします。

問題が解決しないときは、ファーストコンタクトセンターにお問い合わせください。

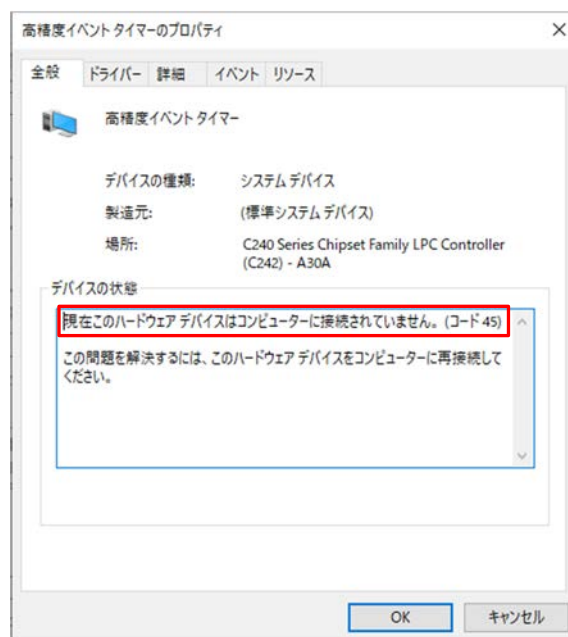
高精度イベントタイマーのプロパティ画面

システムROM v2.52 (09/16/2021)未満の場合、Windows(R) デバイスマネージャに高精度イベントタイマーが表示されず、使用できません。

本問題が発生した場合、高精度イベントタイマーのプロパティに以下のメッセージが表示されます。

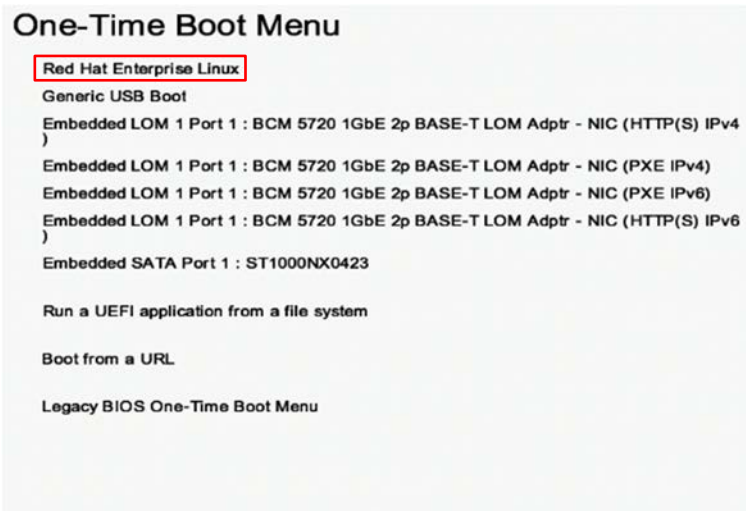
ワンタイムブートメニュー画面

OSがインストールされたHDDやSSDなどのブートデバイスを選択した場合、Red Screen of Death(RSoD)が発生することがあります。

ワンタイムブートメニューから起動する場合、OSブートマネージャー(例: Red Hat Enterprise Linux)を選択してください。

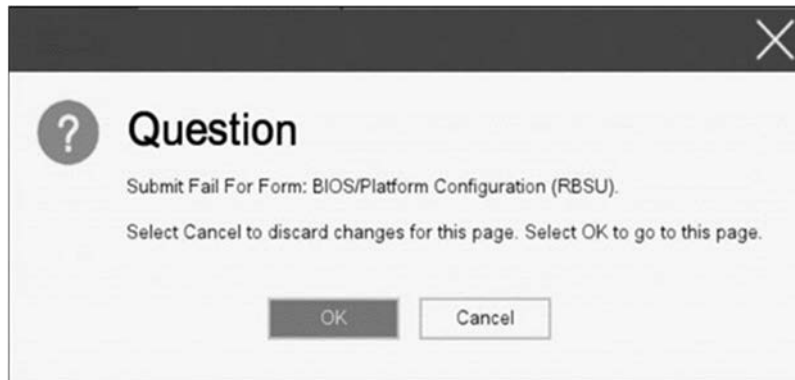
• Caution for the “Submit Fail For Form” Question pop-up

If you encounter the “Submit Fail For Form” Question pop-up while changing the configuration in the System Utilities, **discard the changes by pressing Cancel**. To apply the desired changes after that, reboot the server and re-enter the System Utilities. Selecting OK to continue the changes may cause some server settings such as Serial Number and Product ID to be lost.

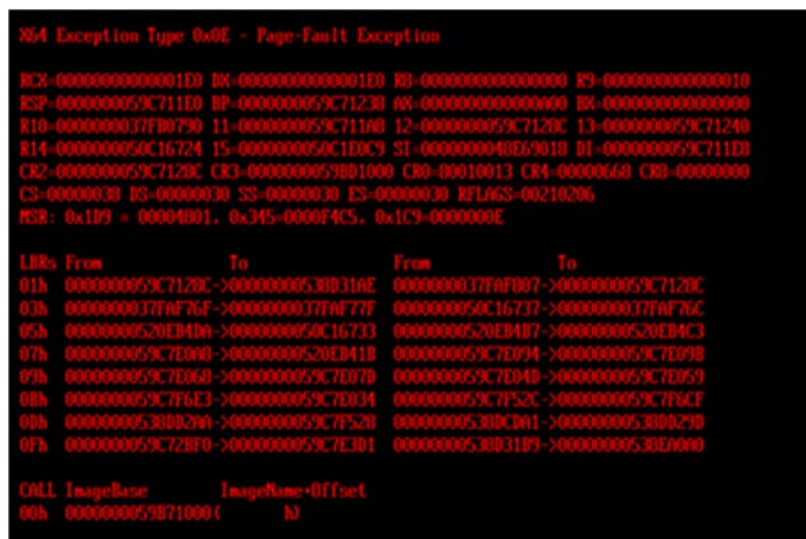
If you have changed the server configuration/settings or the system status, a Red Screen of Death (RSOD) screen appears in rare cases before starting up the OS. This may cause the server to become uncontrollable. However, the server may recover from the RSOD by turning off and then on the power again.

To recover from this condition, power off and then on the server again.

If the problem persists, contact your sales representative for maintenance.

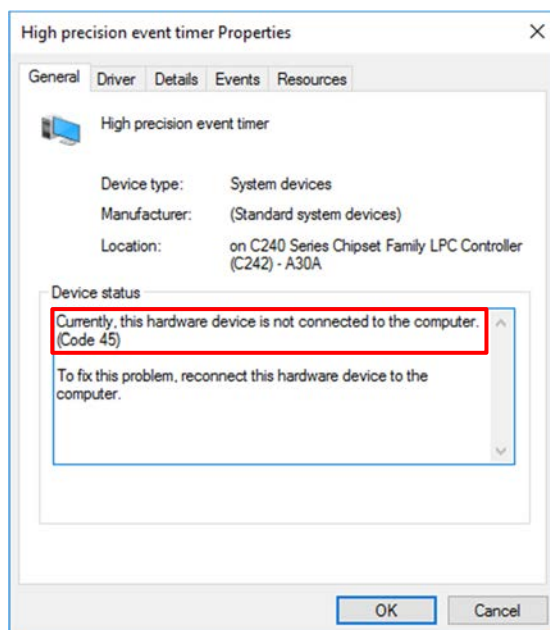
When system ROM version is earlier than v2.52 (09/16/2021), the High Precision Event Timer (HPET) does not displayed in the Windows(R) Device Manager and cannot be used.

When this issue occurs, the following message will be displayed in the properties of the High Precision Event Timer.

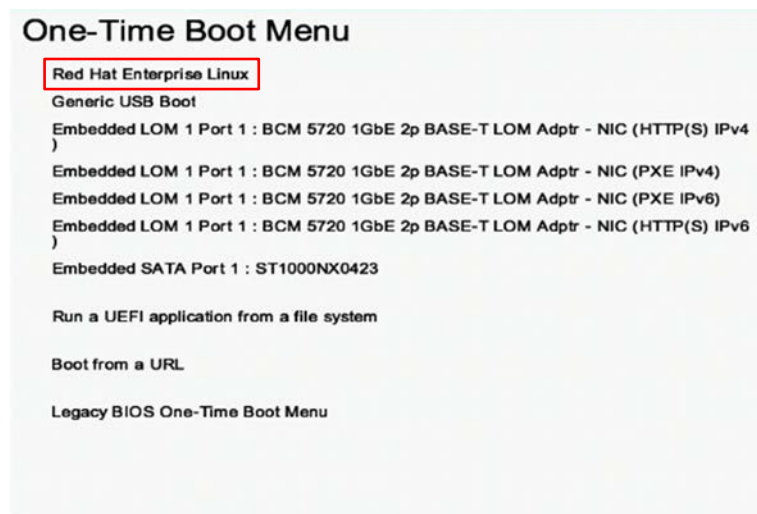
One-Time Boot Screen

Selecting an OS boot device such as HDD/SSD on the "One-Time Boot Menu" may cause RSoD (Red Screen of Death).

Select "OS Boot Manager" when booting OS from "One-Time Boot Menu".
