Express5800/R120i-1M、R120i-2M ご使用時の注意事項

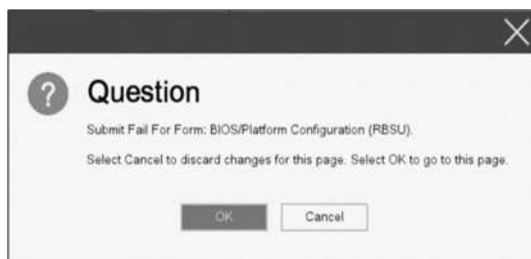
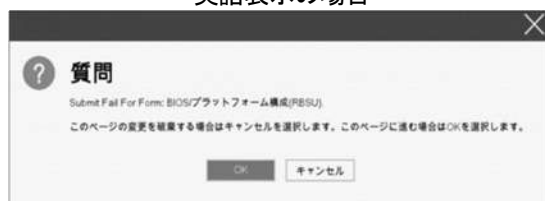
● Submit Fail For FormのQuestion(質問)ポップアップ表示についての注意事項

システムユーティリティにおいて設定の変更中に、次のSubmit Fail For FormのQuestion(質問)ポップアップが表示された場合は、「キャンセル」を選択して変更を破棄してください。

さらに、サーバーの再起動を行ってシステムユーティリティに入りなおしてから設定の変更を再度行ってください。もし「OK」を押してそのまま設定変更を進めると、装置に記録されているSerial Number、Product IDなどの設定情報を消失することがあります。

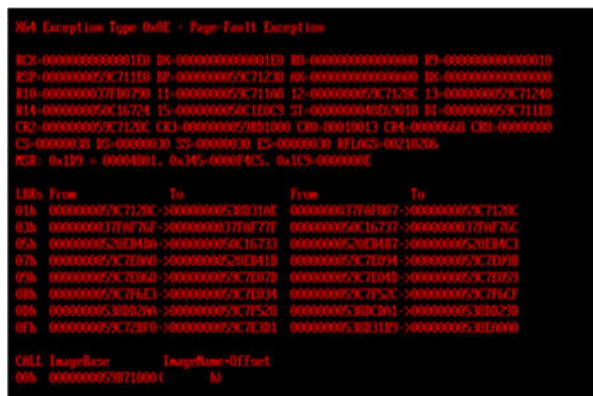
赤文字画面の例

● 赤文字画面(RSOD : Red Screen of Death)が表示された場合の対処について

装置の構成変更や設定変更などシステムの状態を変更した場合や、接続デバイスへのアクセスタイミングにより、OS起動前に稀に赤文字画面(RSOD)が表示され、本製品の操作が出来なくなることがあります。構成変更や設定変更に伴う一過性の事象の場合があり電源OFF/ONによって回復します。

赤文字画面(RSOD)が表示された場合、装置の電源OFF/ONをお願いします。

問題が解決しないときは、ファーストコンタクトセンターにお問い合わせください。

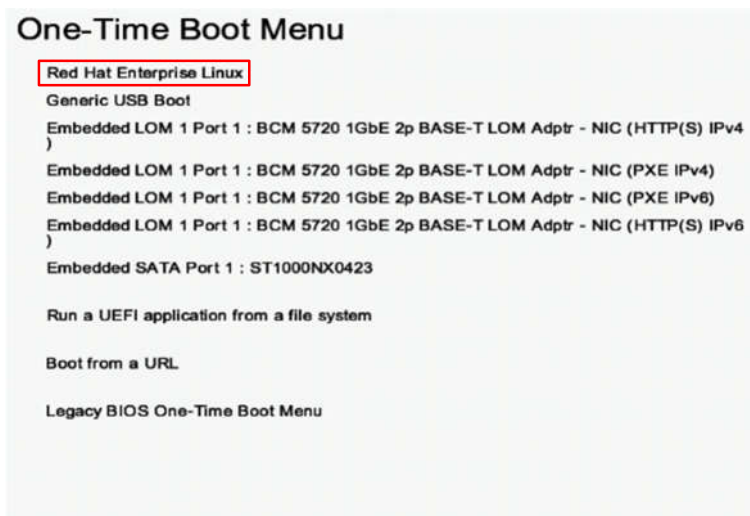
ワンタイムブートメニュー画面

OSがインストールされたHDDやSSDなどのブートデバイスを選択した場合、Red Screen of Death (RSoD)が発生することがあります。

ワンタイムブートメニューから起動する場合、OSブートマネージャー(例: Red Hat Enterprise Linux)を選択してください。

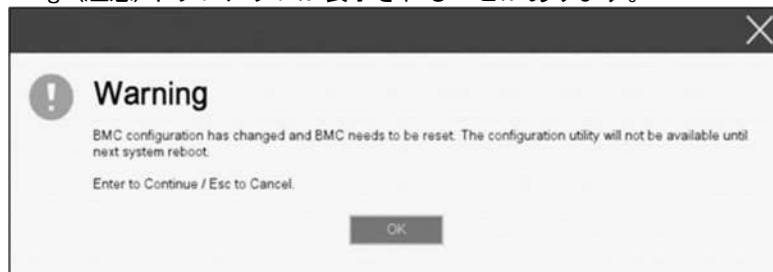
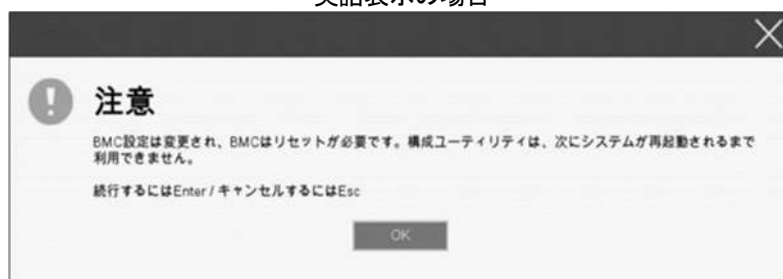
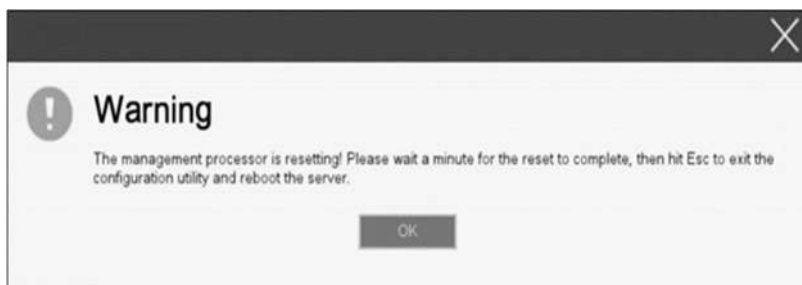
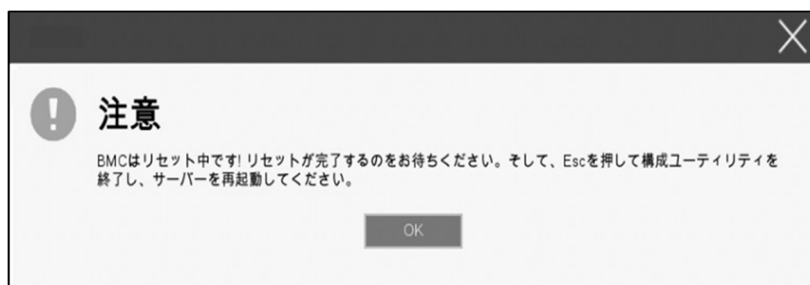
注意事項に従った操作を実施されない場合、「Memory Initialization Start」のメッセージでPOST停止、あるいは、装置に記録されているSerial Number、Product IDの消失が発生する場合があります。

- (1) システムユーティリティの「BMC Configuration Utility」において設定の変更を行うと、iLOの再起動を行うために、次のWarning（注意）ポップアップが表示されることがあります。

- (2) 「OK」を押して進めます。
(3) 次のWarning（注意）ポップアップが表示されます。
このWarning（注意）ポップアップが表示されている状態にて、**必ず1分以上お待ちください。**
その間、何も操作しないでください。

- (4) 1分以上経過後、装置前面のステータスランプが緑色で点灯していることを確認してください。
※ iLOが再起動中 : ステータスランプが緑色で点滅（毎秒1回）
iLOの再起動が完了し正常動作 : ステータスランプが緑色で点灯
(5) 再起動の完了が確認できたら、「OK」を押してください。
(6) <ESC>キーを複数回押してシステムユーティリティの画面に戻ります。
(7) システムユーティリティの「Reboot the System」を選択して再起動します。

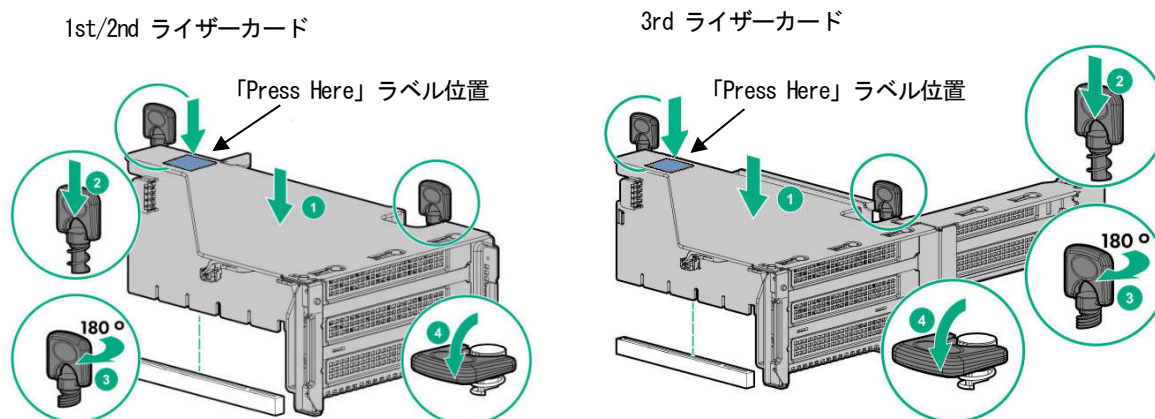
コネクタ勘合不良が起ると、装置前面のStatus LEDが赤点滅します。

赤点滅した場合には本装置を電源OFFしてACケーブルを抜き、ライザーケース上面の「Press Here」ラベル部分を押してください。

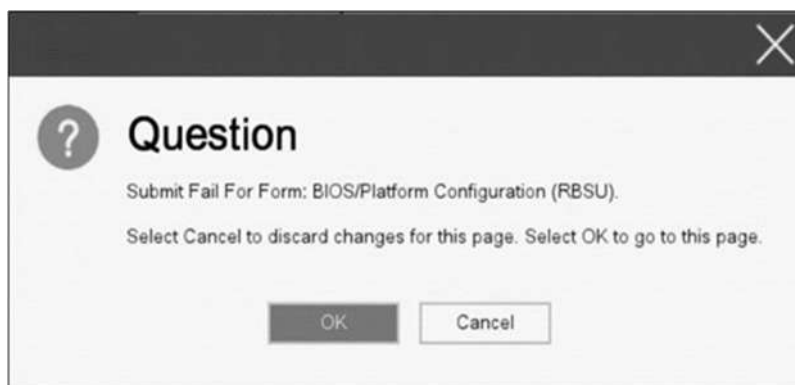
• Caution for the "Submit Fail For Form" Question pop-up

If you encounter the "Submit Fail For Form" Question pop-up while changing the configuration in the System Utilities, **discard the changes by pressing Cancel**. To apply the desired changes after that, reboot the server and re-enter the System Utilities. Selecting OK to continue the changes may cause some server settings such as Serial Number and Product ID to be lost.

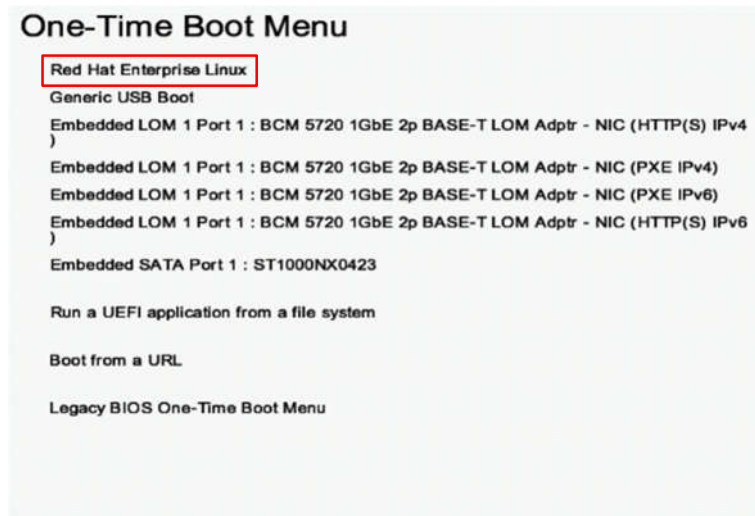
One-Time Boot Screen

Selecting an OS boot device such as HDD/SSD on the "One-Time Boot Menu" may cause RSoD (Red Screen of Death).

Select "OS Boot Manager" when booting OS from "One-Time Boot Menu".

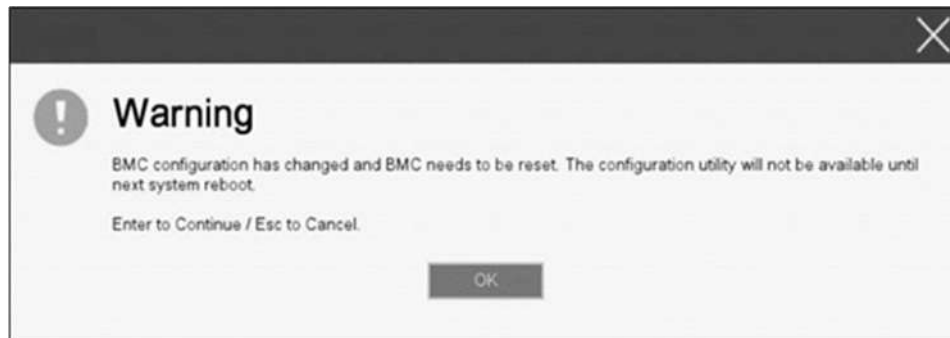
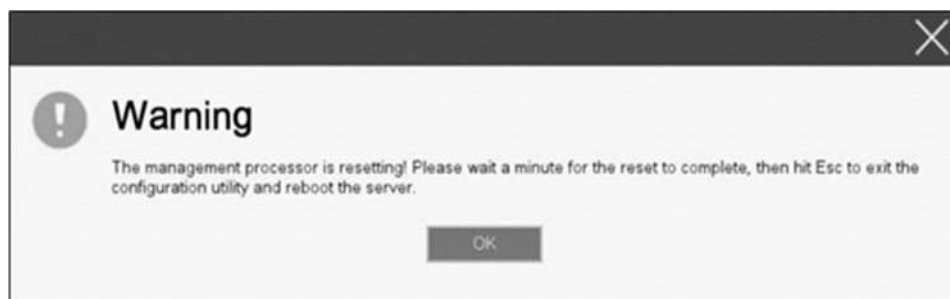
- (1) In the System Utilities, changing the settings of BMC Configuration Utility may display the following pop-up before rebooting the iLO:

- (3) The iLO will start to reboot and then the following pop-up appears:

To avoid this trouble in rebooting the iLO, follow these steps:

- (2) Press OK to proceed.

- (4) Leave this pop-up at least for one minute.

- (5) Confirm if the iLO reboot is completed.

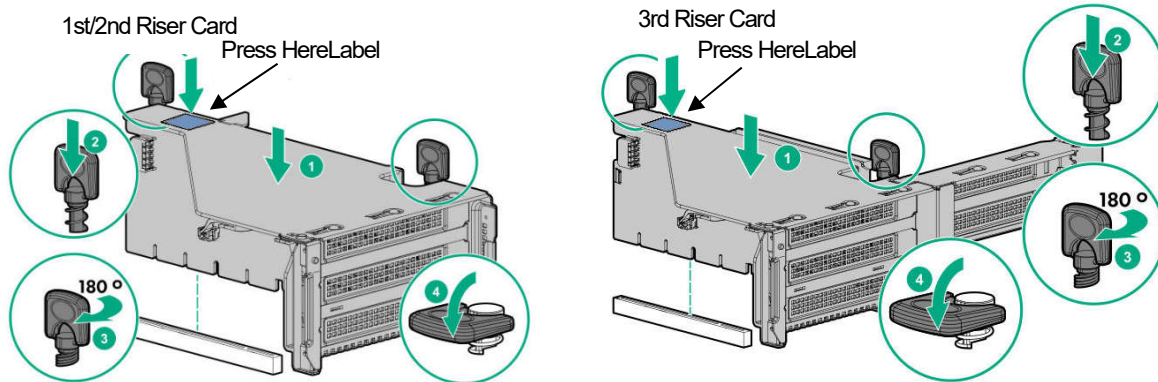
If the connector mismatch occurs, the Status LED on the front of the unit will blink red.

If the Status LED is blinking red, turn off the server, unplug the AC cable, and press the "Press Here" label on the top of the riser cage.
