Express5800/T120h ご使用時の注意事項

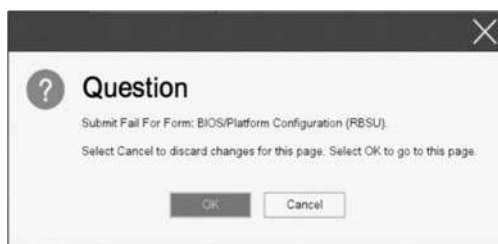
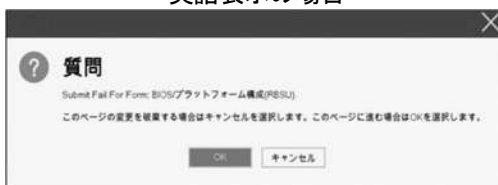
システムユーティリティにおいて設定の変更中に、次のSubmit Fail For FormのQuestion(質問)ポップアップが表示された場合は、「キャンセル」を選択して変更を破棄してください。

さらに、サーバーの再起動を行ってシステムユーティリティに入りなおしてから設定の変更を再度行ってください。もし「OK」を押してそのまま設定変更を進めると、装置に記録されているSerial Number、Product IDなどの設定情報を消失することがあります。

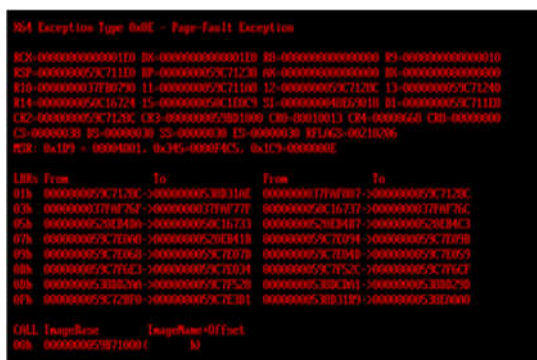
赤文字画面の例

装置の構成変更や設定変更などシステムの状態を変更した場合や、接続デバイスへのアクセスタイミングにより、OS起動前に稀に赤文字画面 (RSOD) が表示され、本製品の操作が出来なくなることがあります。構成変更や設定変更に伴う一過性の事象の場合があり電源OFF/ONによって回復します。

赤文字画面 (RSOD) が表示された場合、装置の電源OFF/ONをお願いします。
問題が解決しないときは、ファーストコンタクトセンターにお問い合わせください。

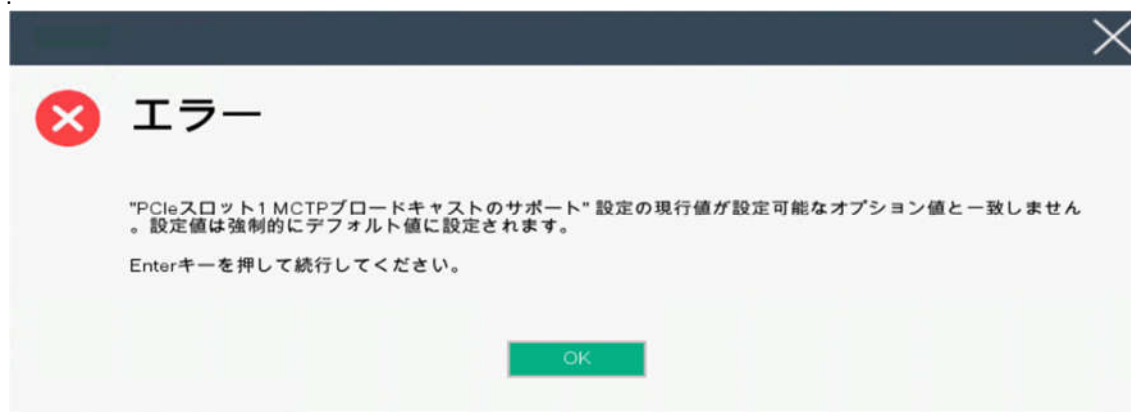
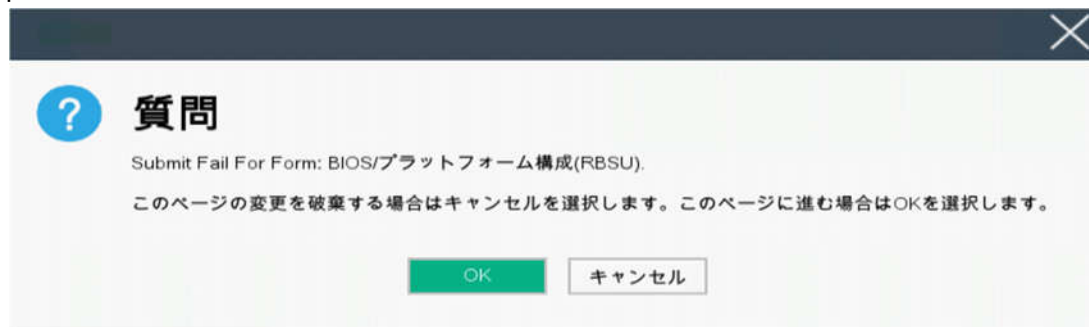
システム ROM バージョン 2.10 (05/21/2019) 以上の装置において、初めて PCIe MCTP Options メニュー(*1) を選択した場合、装置のデフォルト設定を強制的に設定する旨のポップアップ(*2) が、設定可能な PCIe Slot 数分表示されます。

なお、下記システム ROM バージョンの場合、設定保存時にポップアップ(*3) が表示され設定は保存されません。保存されないことにより、本メニューを表示させるたびに PCIe Slot 数分のポップアップ(*2) が表示されることになります。この場合、MCTP Broadcast は常に有効で動作します。

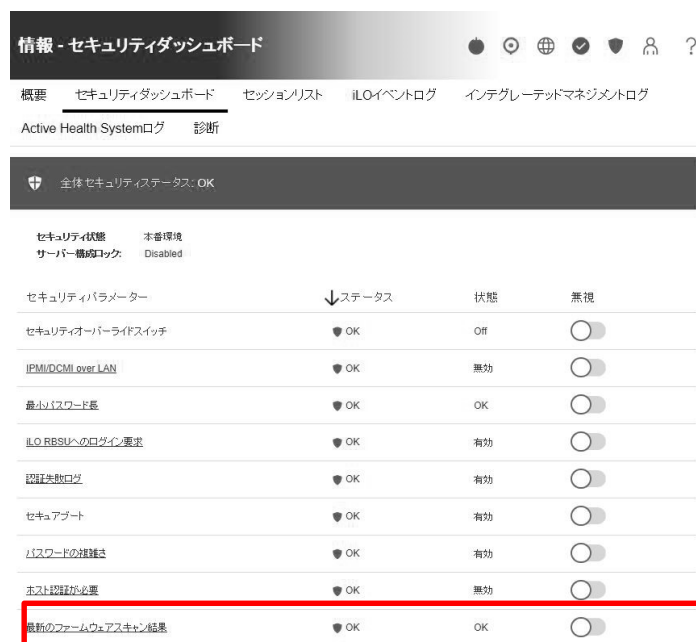
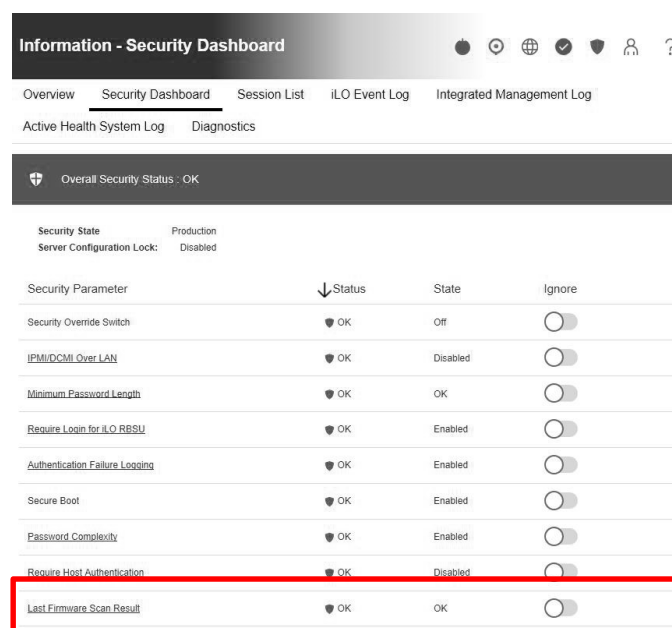
iLO 5ファームウェアバージョン1.43以上、2.10未満をご使用の場合、[Information] - [Security Dashboard]に[Last Firmware Scan Result]が表示されますが、本ハイパーリンクをクリックしないでください。

誤ってクリックした場合、Webサイト内のメニュー間移動が出来なくなります。その場合、ブラウザーのリロードボタンをクリックするか、もしくはいったんiLO Webインターフェースのログアウトを実行して再度ログインしてください。

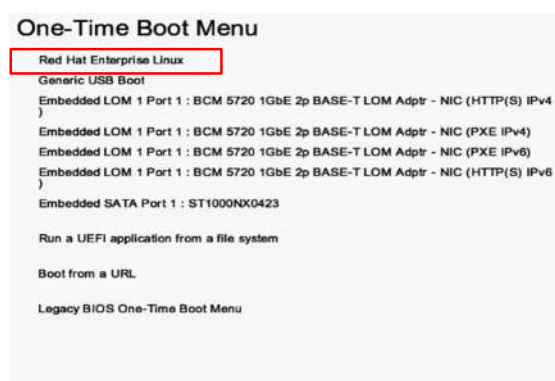
ワンタイムブートメニュー画面

OSがインストールされたHDDやSSDなどのブートデバイスを選択した場合、Red Screen of Death (RSoD)が発生することがあります。

ワンタイムブートメニューから起動する場合、OSブートマネージャー(例: Red Hat Enterprise Linux)を選択してください。

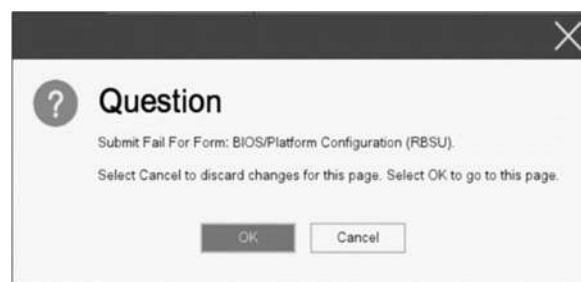
If you encounter the “Submit Fail For Form” Question pop-up while changing the configuration in the System Utilities, **discard the changes by pressing Cancel**. To apply the desired changes after that, reboot the server and re-enter the System Utilities. Selecting OK to continue the changes may cause some server settings such as Serial Number and Product ID to be lost.

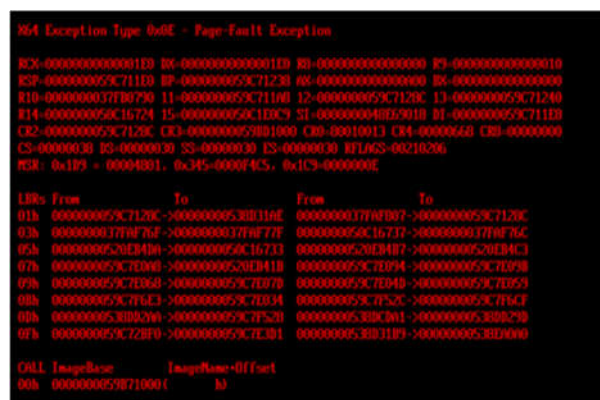
If you have changed the server configuration/settings or the system status, a Red Screen of Death (RSOD) screen appears in rare cases before starting up the OS. This may cause the server to become uncontrollable. However, the server may recover from the RSOD by turning off and then on the power again.

To recover from this condition, power off and then on the server again.

If the problem persists, contact your sales representative for maintenance.
