Express5800/R120h-1M (3rd-Gen), R120h-2M (3rd-Gen)

ご使用時の注意事項

Precautions for Using Express5800/R120h-1M (3rd-Gen), R120h-2M (3rd-Gen)

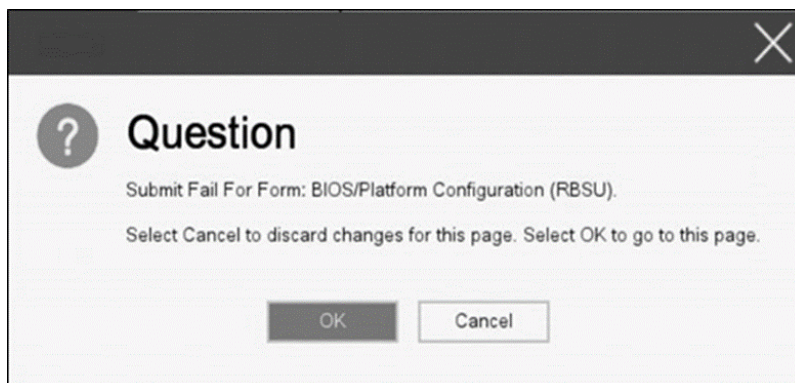
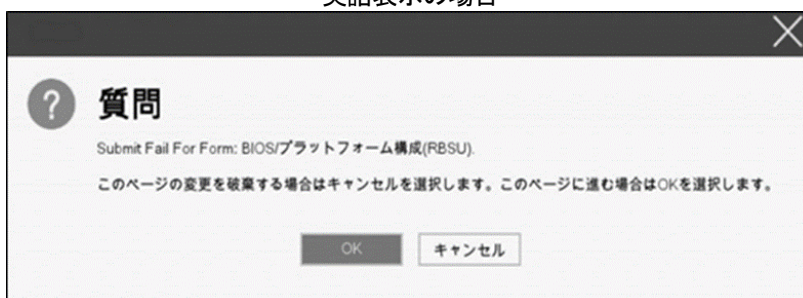
システムユーティリティにおいて設定の変更中に、次のSubmit Fail For FormのQuestion(質問)ポップアップが表示された場合は、「キャンセル」を選択して変更を破棄してください。

さらに、サーバーの再起動を行ってシステムユーティリティに入りなおしてから設定の変更を再度行ってください。もし「OK」を押してそのまま設定変更を進めると、装置に記録されているSerial Number、Product IDなどの設定情報を消失することがあります。

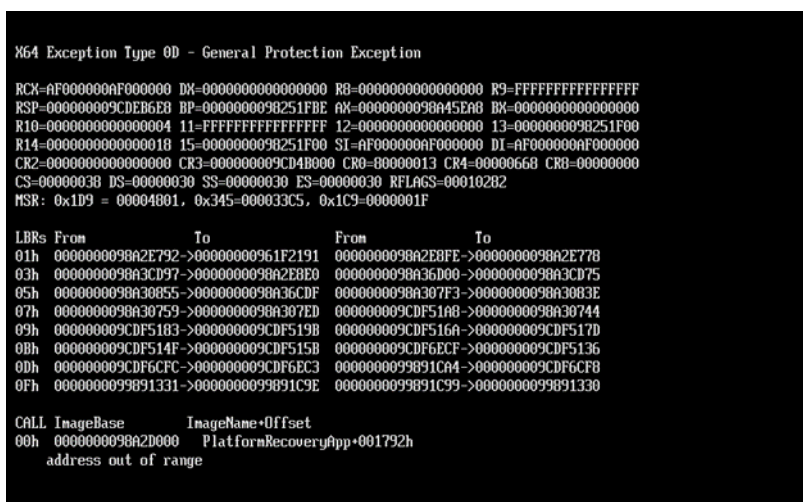
赤文字画面の例

装置の構成変更や設定変更などシステムの状態を変更した場合や、接続デバイスへのアクセスタイミングにより、OS起動前に稀に赤文字画面 (RSOD)が表示され、本製品の操作が出来なくなることがあります。構成変更や設定変更に伴う一過性の事象の場合があり電源OFF/ONによって回復します。

赤文字画面 (RSOD)が表示された場合、装置の電源OFF/ONをお願いします。
問題が解決しないときは、保守サービス会社にお問い合わせください。

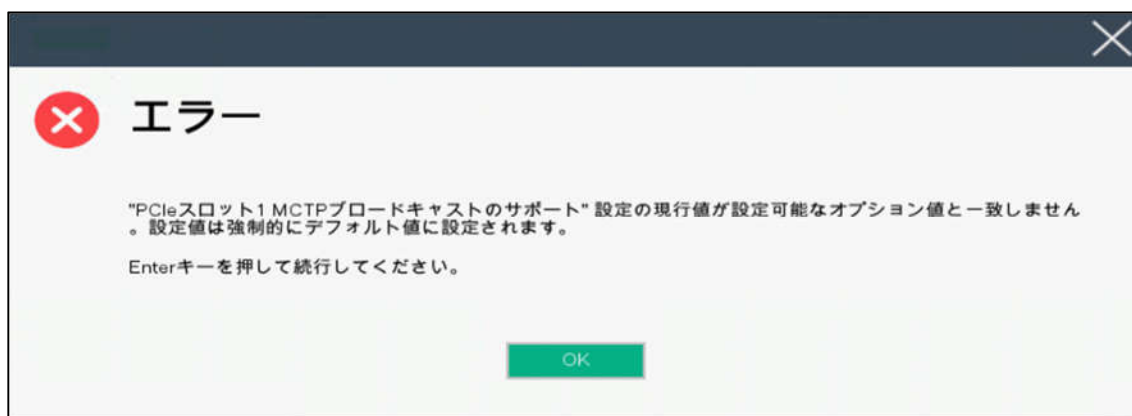
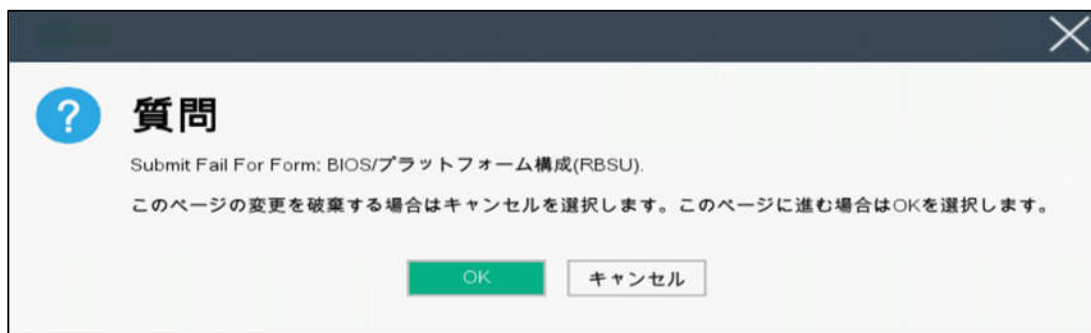
システム ROM バージョンが v2.10 (05/21/2019) 以降の装置において、初めて PCIe MCTP Options メニュー(*1) を選択した場合、装置のデフォルト設定を強制的に設定する旨のポップアップ(*2)が、設定可能な PCIe Slot 数分表示されます。

尚、下記システム ROM バージョンの場合、設定保存時にポップアップ(*3)が表示され設定は保存されません。保存されない事により、本メニューを表示させるたびに PCIe Slot 数分のポップアップ(*2)が表示される事になります。この場合、MCTP Broadcast は常に有効で動作します。

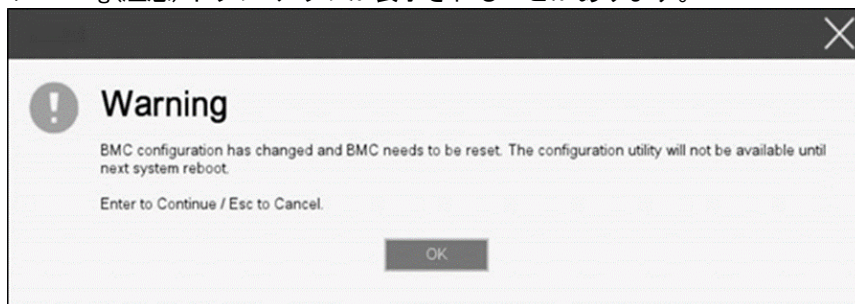
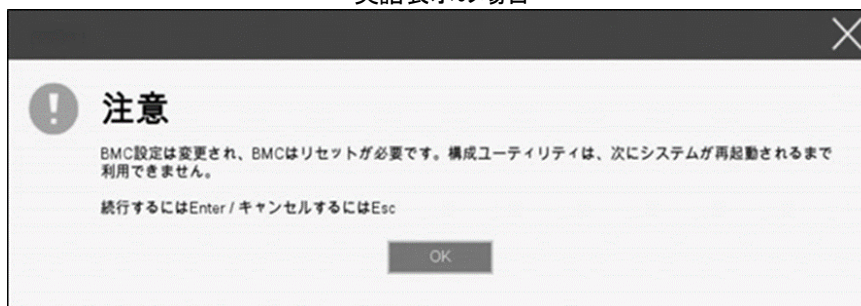
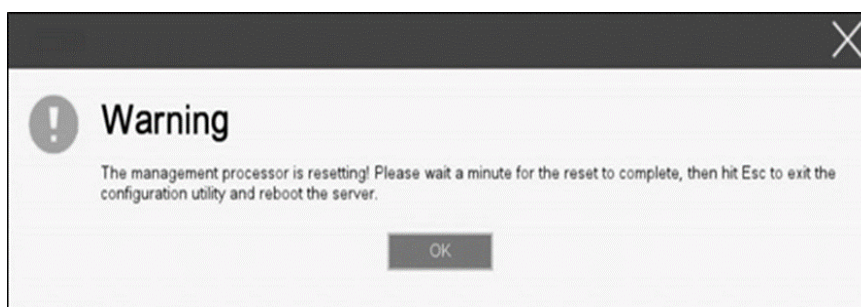
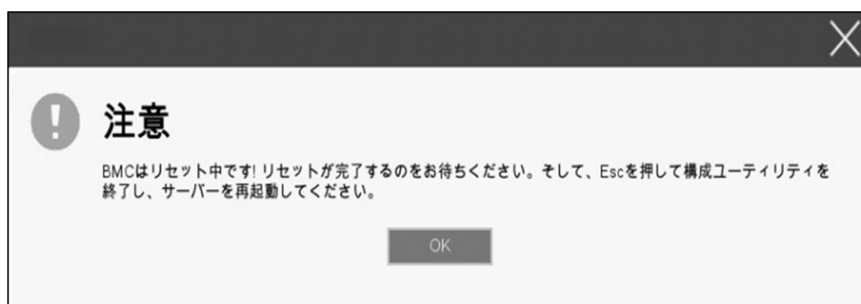
注意事項に従った操作を実施されない場合、「Memory Initialization Start」のメッセージでPOST停止、あるいは、装置に記録されているSerial Number、Product IDの消失が発生する場合があります。

- (1) システムユーティリティの「BMC Configuration Utility」において設定の変更を行うと、iLOの再起動を行うために、次のWarning(注意)ポップアップが表示されることがあります。

- (3) 次のWarning(注意)ポップアップの表示されます。

このWarning(注意)ポップアップが表示されている状態にて、**必ず1分以上お待ちください。**その間、何も操作しないでください。

(4) 1分以上経過後、装置前面のステータスランプが緑色で点灯していることを確認してください。

(5) 再起動の完了が確認できたら、「OK」を押してください。

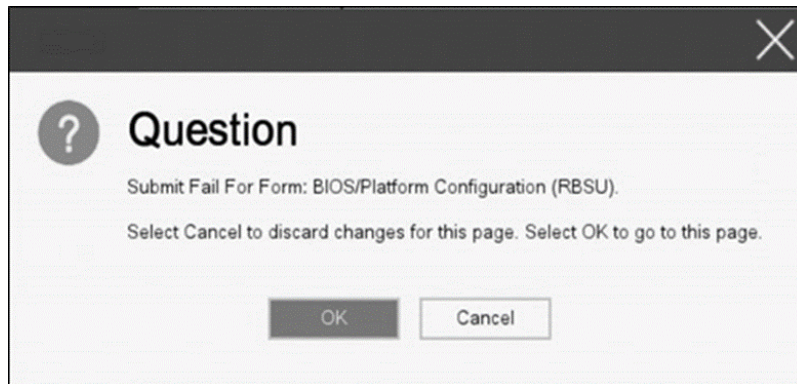
If you encounter the “Submit Fail For Form” Question pop-up while changing the configuration in the System Utilities, **discard the changes by pressing Cancel**. To apply the desired changes after that, reboot the server and re-enter the System Utilities. Selecting OK to continue the changes may cause some server settings such as Serial Number and Product ID to be lost.

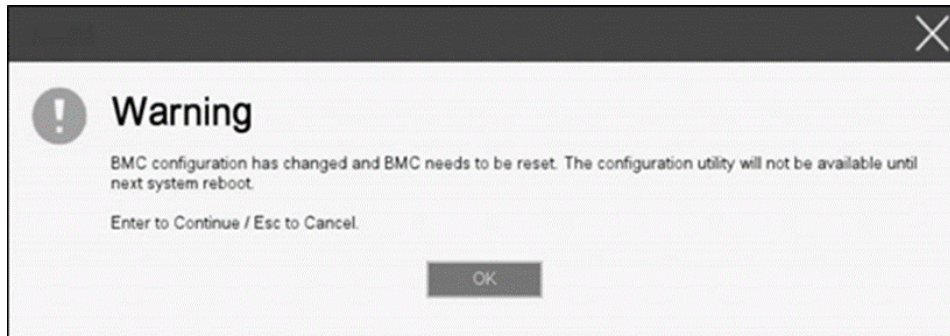
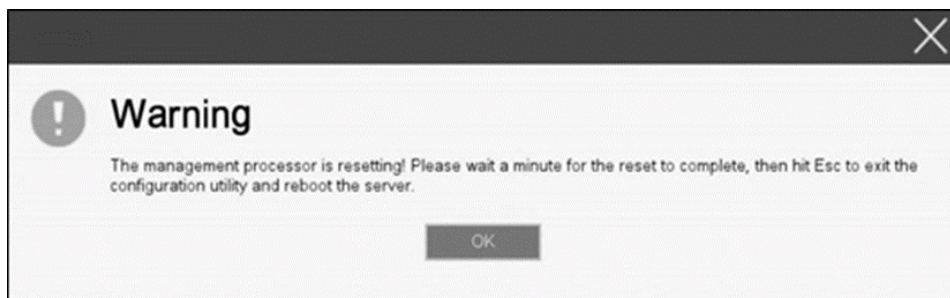
- (1) In the System Utilities, changing the settings of BMC Configuration Utility may display the following pop-up before rebooting the iLO:

- (3) The iLO will start to reboot and then the following pop-up appears:

- (4) Leave this pop-up at least for one minute.
- (5) Confirm if the iLO reboot is completed.
 - ※the iLO is restarting : the Status LED flashes in green (once per second) the iLO is operating normally through the restart completion : the Status LED lights in green.
- (6) If the confirmation succeeds, press OK to proceed.
- (7) Press the ESC key several times to return to the top screen of the System Utilities.
- (8) From the top screen, select Reboot the System to reboot the server.
