# Express5800/T120h ご使用時の注意事項

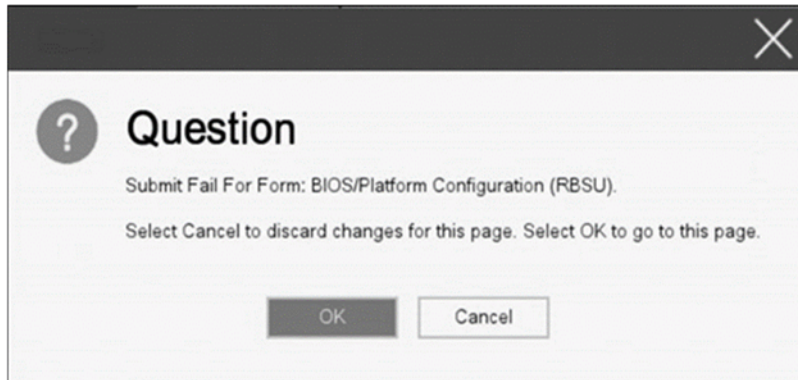
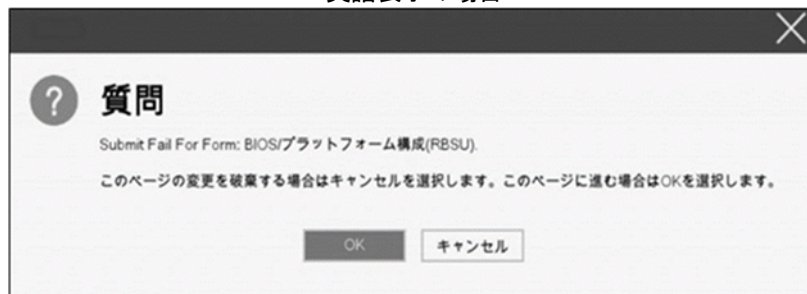
システムユーティリティにおいて設定の変更中に、次の Submit Fail For Form の Question(質問) ポップアップが表示された場合は、「キャンセル」を選択して変更を破棄してください。

さらに、サーバーの再起動を行ってシステムユーティリティに入りなおしてから設定の変更を再度行ってください。もし「OK」を押してそのまま設定変更を進めると、装置に記録されている Serial Number、Product ID などの設定情報を消失することがあります。

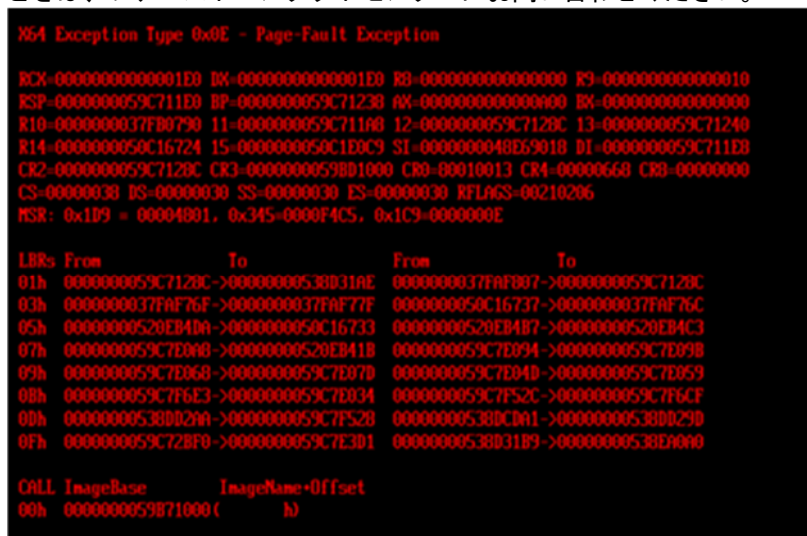
赤文字画面の例

装置の構成変更や設定変更などシステムの状態を変更した場合や、接続デバイスへのアクセスタイミングにより、OS起動前に稀に赤文字画面 (RSOD) が表示され、本製品の操作が出来なくなることがあります。構成変更や設定変更に伴う一過性の事象の場合があり電源OFF/ONによって回復します。

赤文字画面 (RSOD) が表示された場合、装置の電源OFF/ONをお願いします。

問題が解決しないときは、ファーストコンタクトセンターにお問い合わせください。

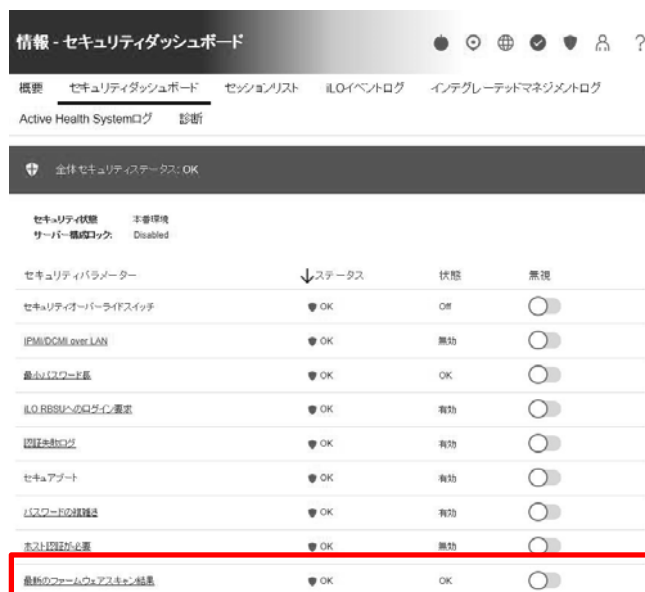
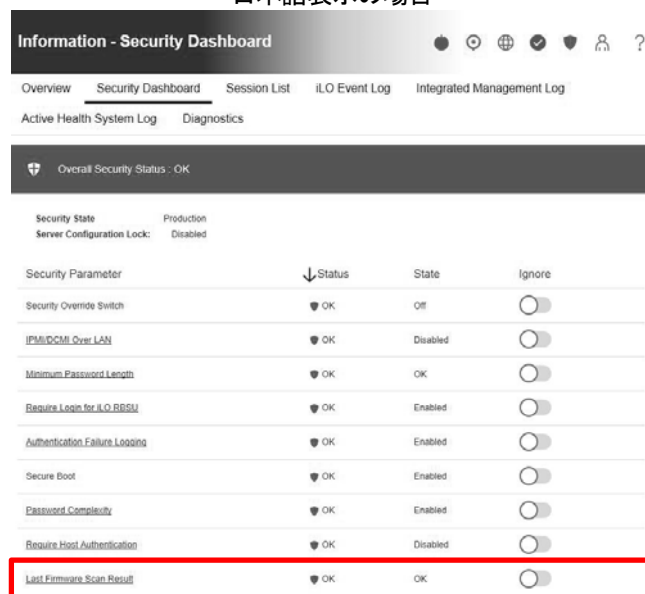
iLO 5ファームウェア1.43以上、2.10未満をご使用の場合、[Information] - [Security Dashboard]に[Last Firmware Scan Result]が表示されますが、本ハイパーリンクをクリックしないでください。

誤ってクリックした場合、Webサイト内のメニュー間移動が出来なくなります。その場合、ブラウザのリロードボタンをクリックするか、もしくはいったんiLO Webインターフェースのログアウトを実行して再度ログインしてください。

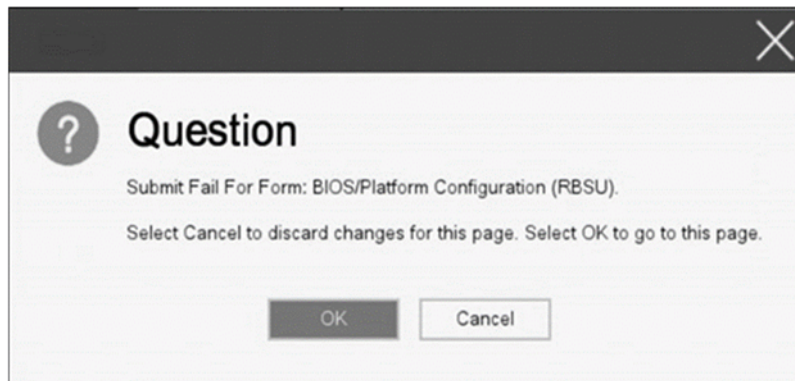
If you encounter the “Submit Fail For Form” Question pop-up while changing the configuration in the System Utilities, **discard the changes by pressing Cancel**. To apply the desired changes after that, reboot the server and re-enter the System Utilities. Selecting OK to continue the changes may cause some server settings such as Serial Number and Product ID to be lost.

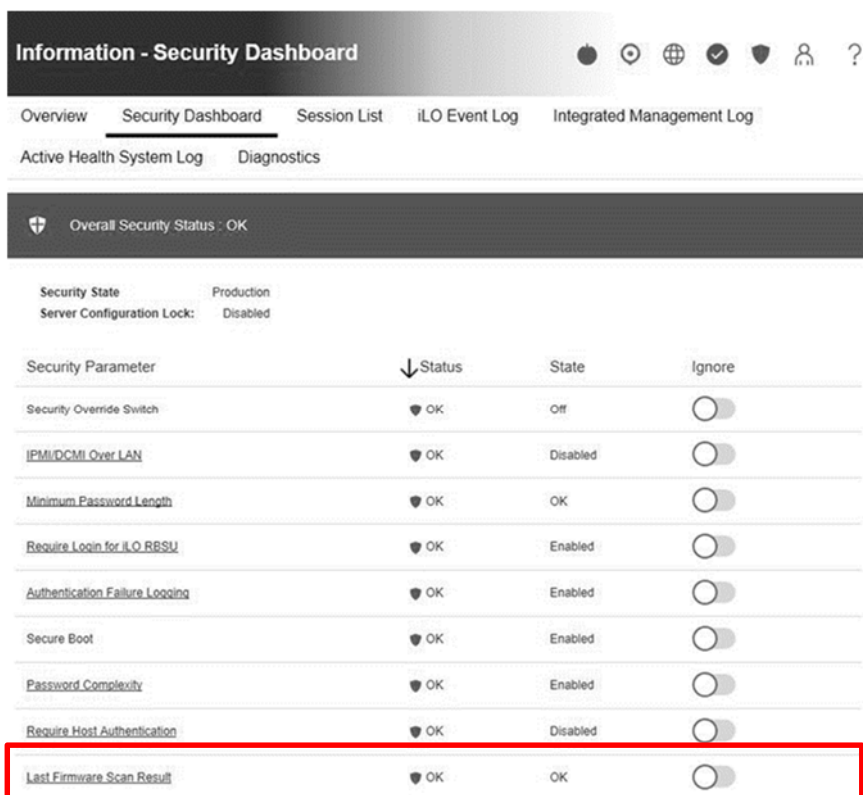
In that case, you need to reload the page by the reload button of the browser.

Or you log out the current session of iLO Web interface, and please log in again.
