Express5800/R120i-1M、R120i-2Mご使用時の注意事項

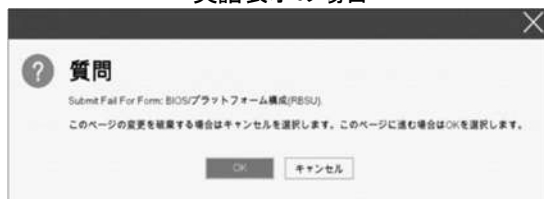
● Submit Fail For FormのQuestion(質問)ポップアップ表示についての注意事項

システムユーティリティにおいて設定の変更中に、次のSubmit Fail For FormのQuestion(質問)ポップアップが表示された場合は、「キャンセル」を選択して変更を破棄してください。

さらに、サーバーの再起動を行ってシステムユーティリティに入りなおしてから設定の変更を再度行ってください。もし「OK」を押してそのまま設定変更を進めると、装置に記録されているSerial Number、Product IDなどの設定情報を消失することがあります。

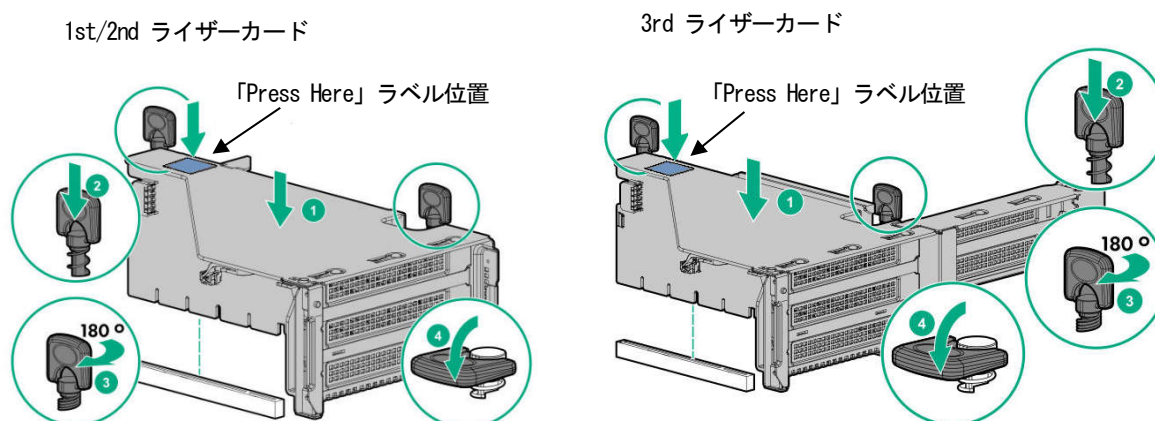
コネクタ勘合不良が起こると、装置前面のStatus LEDが赤点滅します。

赤点滅した場合には本装置を電源OFFしてACケーブルを抜き、ライザーケース上面の「Press Here」ラベル部分を押してください。

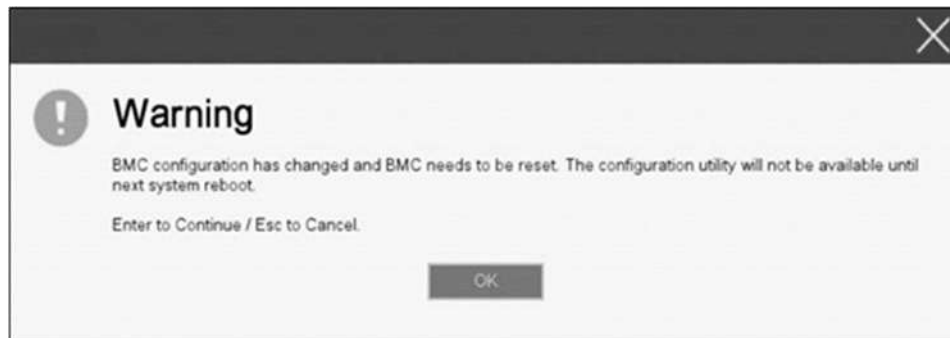
- (1) In the System Utilities, changing the settings of BMC Configuration Utility may display the following pop-up before rebooting the iLO:

- (2) Press OK to proceed.

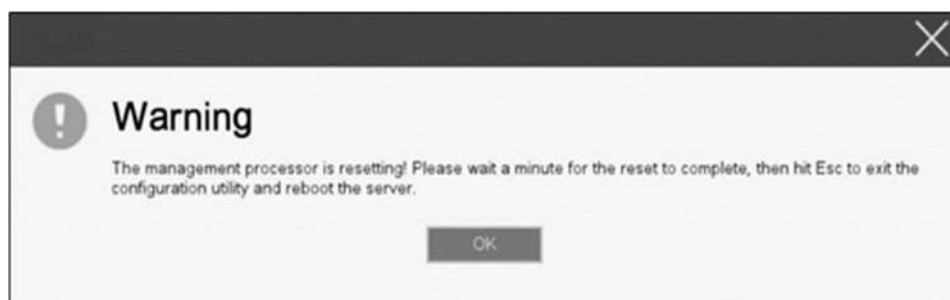
- (3) The iLO will start to reboot and then the following pop-up appears:

- (4) Leave this pop-up at least for one minute.

- (5) Confirm if the iLO reboot is completed.

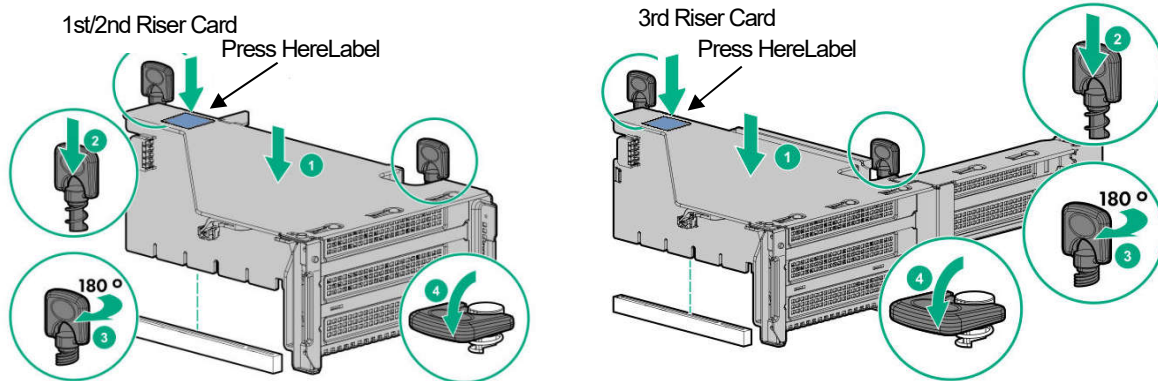
If the connector mismatch occurs, the Status LED on the front of the unit will blink red.

If the Status LED is blinking red, turn off the server, unplug the AC cable, and press the "Press Here" label on the top of the riser cage.
