Express5800/GT110e, GT110e-S, R110e-1E

ご使用時の注意事項

Precautions for Using Express5800/GT110e,GT110e-S,R110e-1E

5th Edition: April 2013

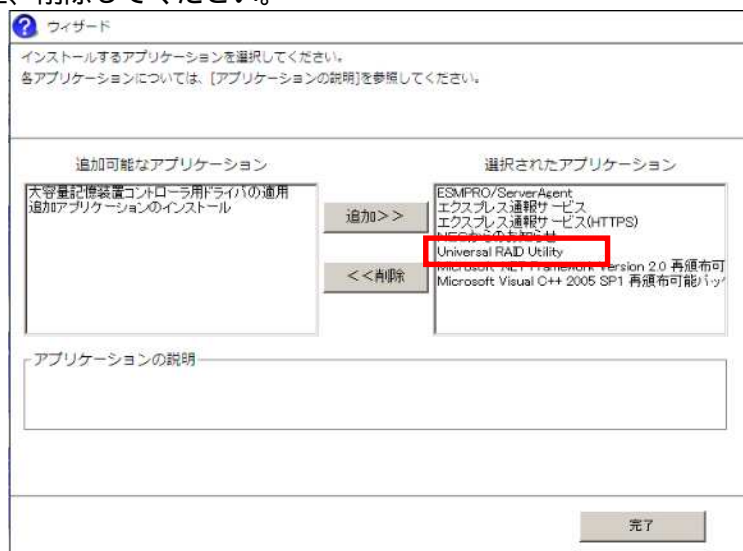
EXPRESSBUILDER を使ったセットアップの場合、アプリケーションの設定からUniversal RAID Utilityを一旦、削除してください。

OSインストール後、以下のURLを参照し、RAIDコントローラのドライバをアップデートしてください。

RAIDドライバのアップデート完了後、Universal RAID Utilityをインストールしてください。

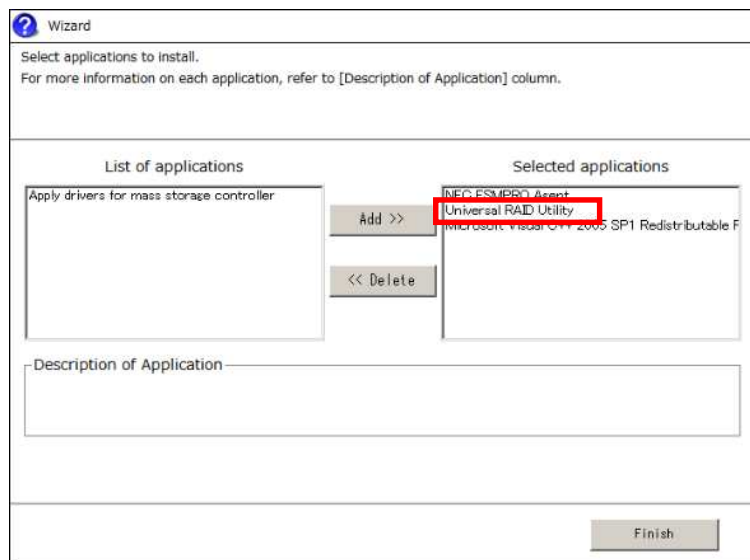
To set up the system by using EXPRESSBUIDLER, delete Universal RAID Utility from the Application settings.

After installing the OS, refer to the URL below and update the driver for the RAID Controller.

After updating the RAID driver, install Universal RAID Utility.

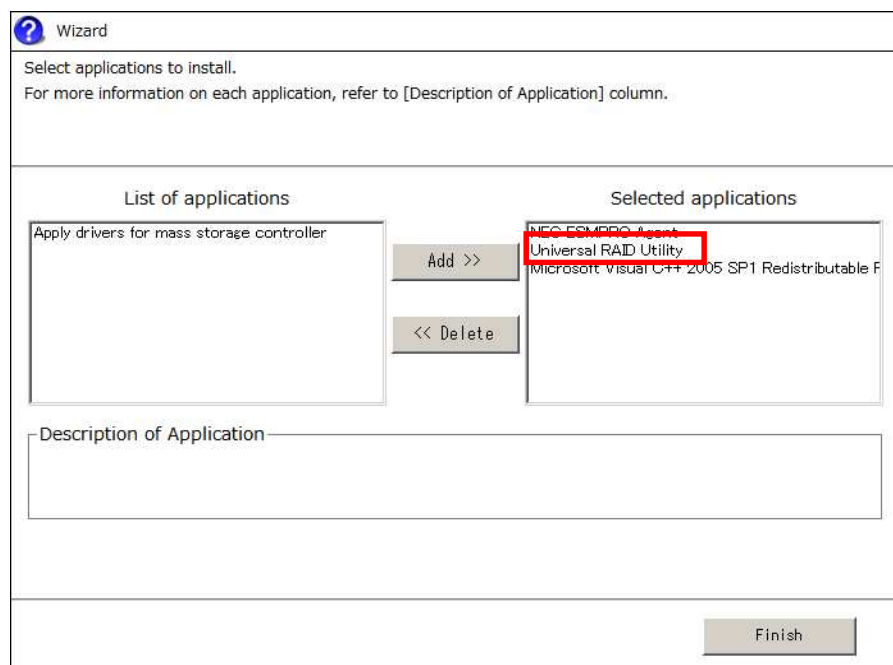
使用EXPRESSBUILDER进行设置时，请通过应用程序的设置删除Universal RAID Utility。

安装OS后，请参考下面的URL，升级RAID控制器的驱动程序。

升级RAID驱动程序后，安装Universal RAID Utility。
