# [ 重要 ]

## B120d-h, B120d, B110d ご使用にあたって

# [ Important Information ]

## NEC Express5800/B120d-h, B120d, B110d

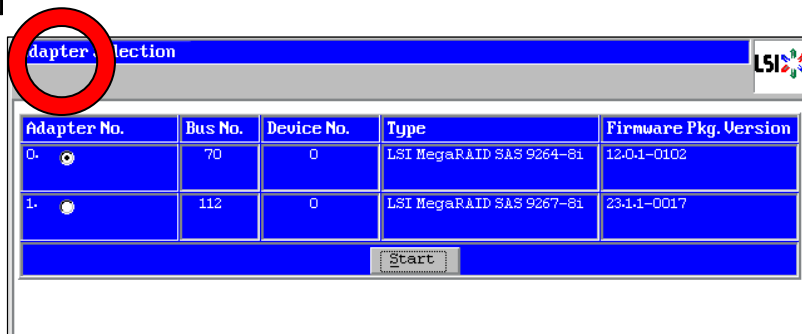
### 正しいユーティリティ(WebBIOS)起動画面

複数のRAIDコントローラが認識されます。  
“Type”欄が『LSI MegaRAID SAS 9267-8i』と表示されているアダプタが『N8403-059 RAIDコントローラ』で、もう一方が『増設HDDブレードに内蔵のRAIDコントローラ』です。  
コンフィグレーションの対象を選択して、[Start]をクリックします。  
その後の手順については、RAIDコントローラユーザズガイドを参照してください。

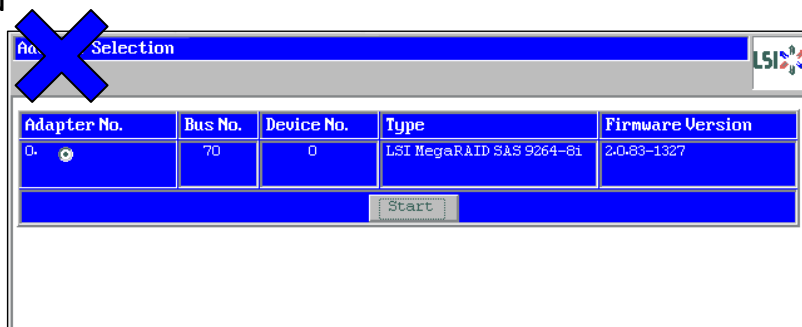
### 誤ったユーティリティ(WebBIOS)起動画面

RAIDコントローラが一つしか認識されません。  
この画面のように、RAIDコントローラが一つしか認識されていない場合は、装置を再起動してPOSTの実行からやりなおしてください。

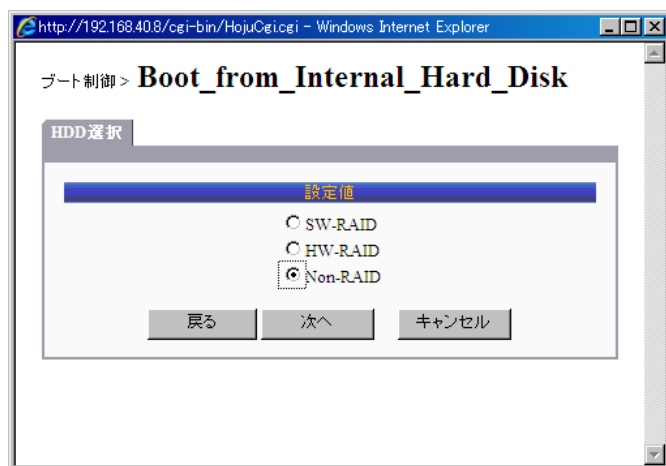
ブート制御機能を使用して、内蔵HDDのRAIDモード設定画面で「Non-RAID」を選択した場合、SATAの動作モードが自動的に「AHCIモード」に設定されますが、本製品ではSATA AHCIモードはサポートしておりません。

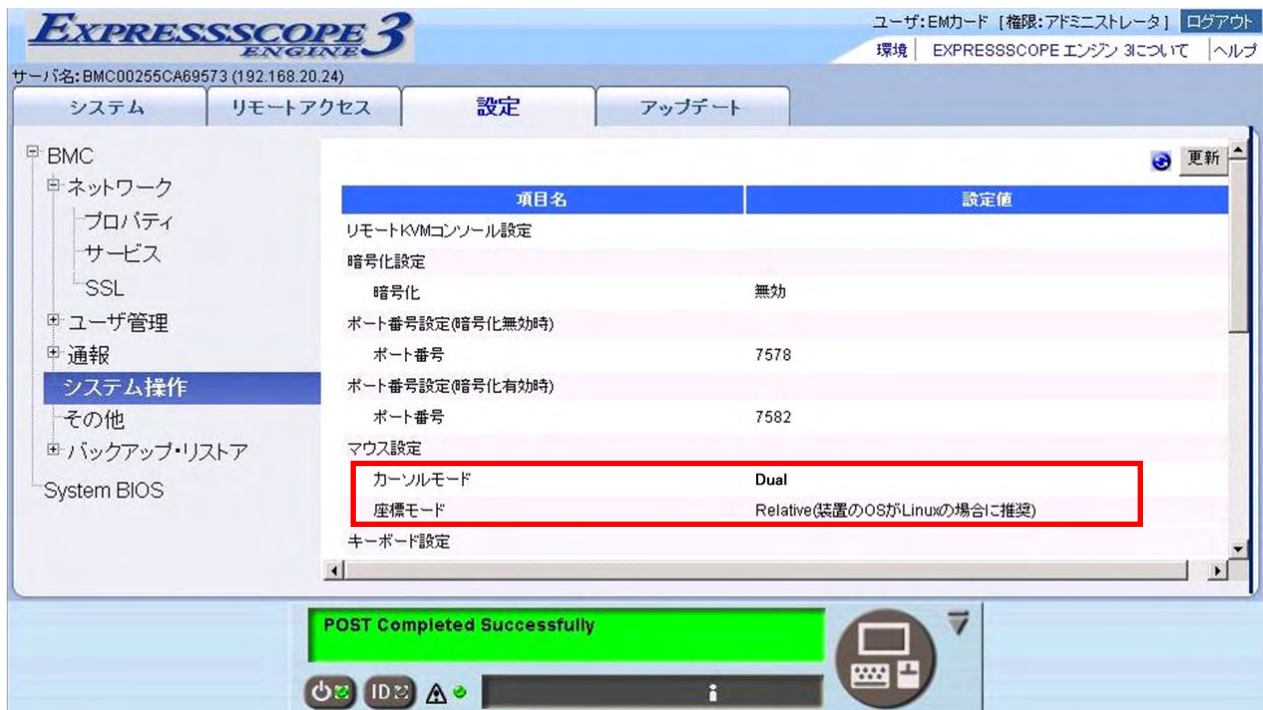
本製品のEXPRESSSCOPEエンジン 3 リモートKVM機能をご使用頂くにあたり、下記のディスクアレイコントローラのWEB BIOS上でマウスによる操作ができません。

EXPRESSSCOPEエンジン 3 リモートKVM機能を使用して、WEB BIOSにてディスクアレイコントローラの設定を行う場合、EXPRESSSCOPEエンジン 3の「設定」タブを選択し、「BMC」→「システム操作」→「マウス設定」の「カーソルモード」を「Dual」に、「座標モード」を「Relative」に変更してください。

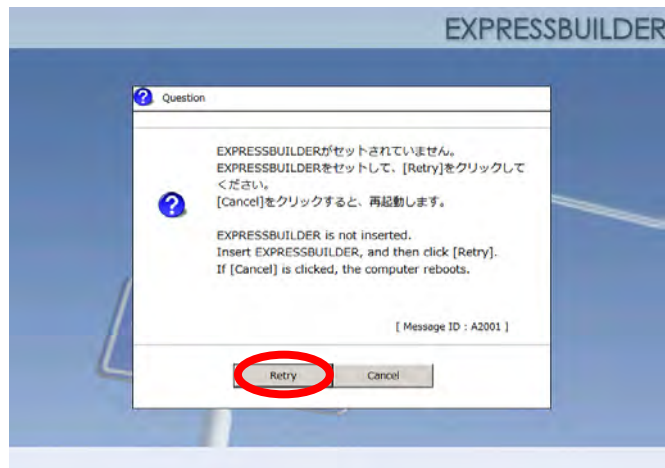
本製品を SIGMABLADE-M(N8405-016B/016C) に実装してご使用になる場合、SIGMABLADE-M に内蔵のDVDドライブから EXPRESSBUILDER DVDを起動し「OS installation」を選択した際に、下記のメッセージが表示される場合があります。

この場合は、SIGMABLADE-M に内蔵のDVDドライブを別の Bladeに選択し、再度インストール対象の Bladeに選択し直した後に、Retryボタンをクリックしてインストールを続行してください。

DVDドライブを再選択後、EXPRESSBUILDERの読み込みに時間がかかる場合がありますので、Retryボタンをクリックしても画面が先に進まない場合は、10秒ほど待ってから再度 Retryボタンをクリックするようにしてください。

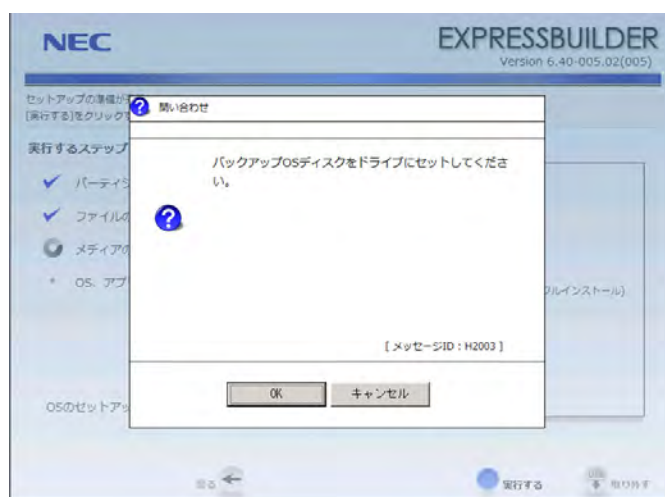
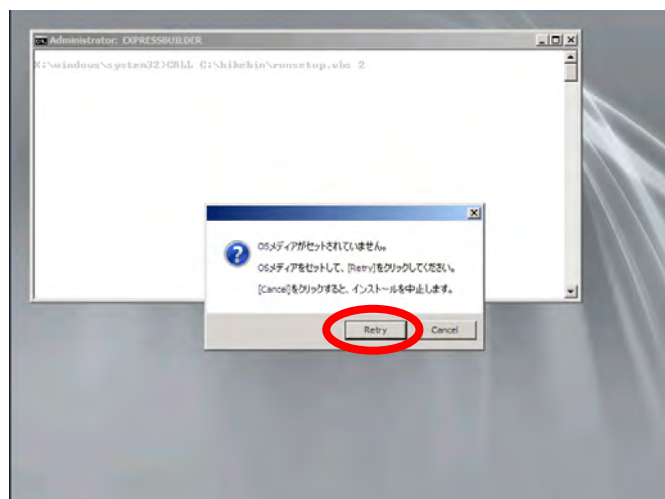
また、本機能を用いてOSのセットアップをする場合、下記のメッセージに従いバックアップOSディスクをドライブにセットして作業を進めた時に、次のようなメッセージが表示されることがあります。

この場合も、SIGMABLADE-M に内蔵のDVDドライブを別の Bladeに選択し、再度インストール対象の Bladeに選択し直した後に、Retryボタンをクリックしてインストールを続行してください。

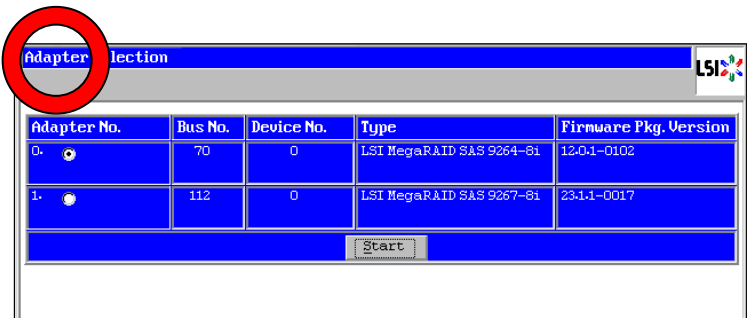
### Correct utility

Two RAID controllers are recognized.  
“LSI MegaRAID SAS 9267-8i” indicates  
"N8403-059F RAID Controller kit",  
and the other indicates the RAID controller  
of "Storage and I/O Blade AD106b".  
Select a configuration type, and click [Start].  
For the steps to proceed, refer to the user's  
guide.

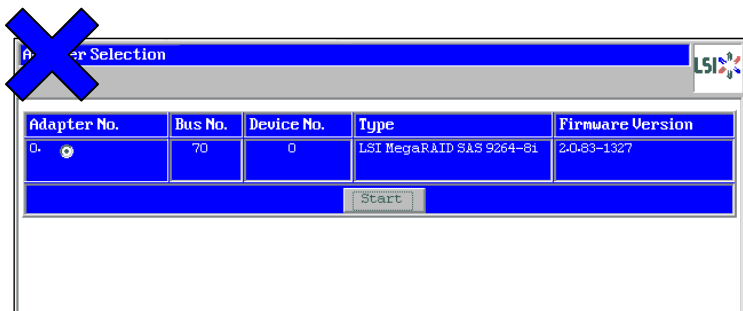
### Wrong utility

Only one RAID controller is recognized.  
In this case, please restart the server  
and rerun POST to try again.

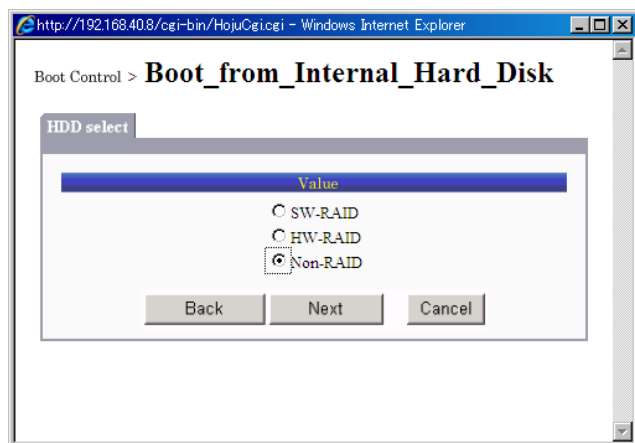
When “Non-RAID” is selected on the RAID mode settings screen of the internal hard disk drive using the Boot Control function, SATA mode is automatically set to “AHCI mode”, even though SATA AHCI mode is not supported by Express5800/B120d-h, B120d and B110d.

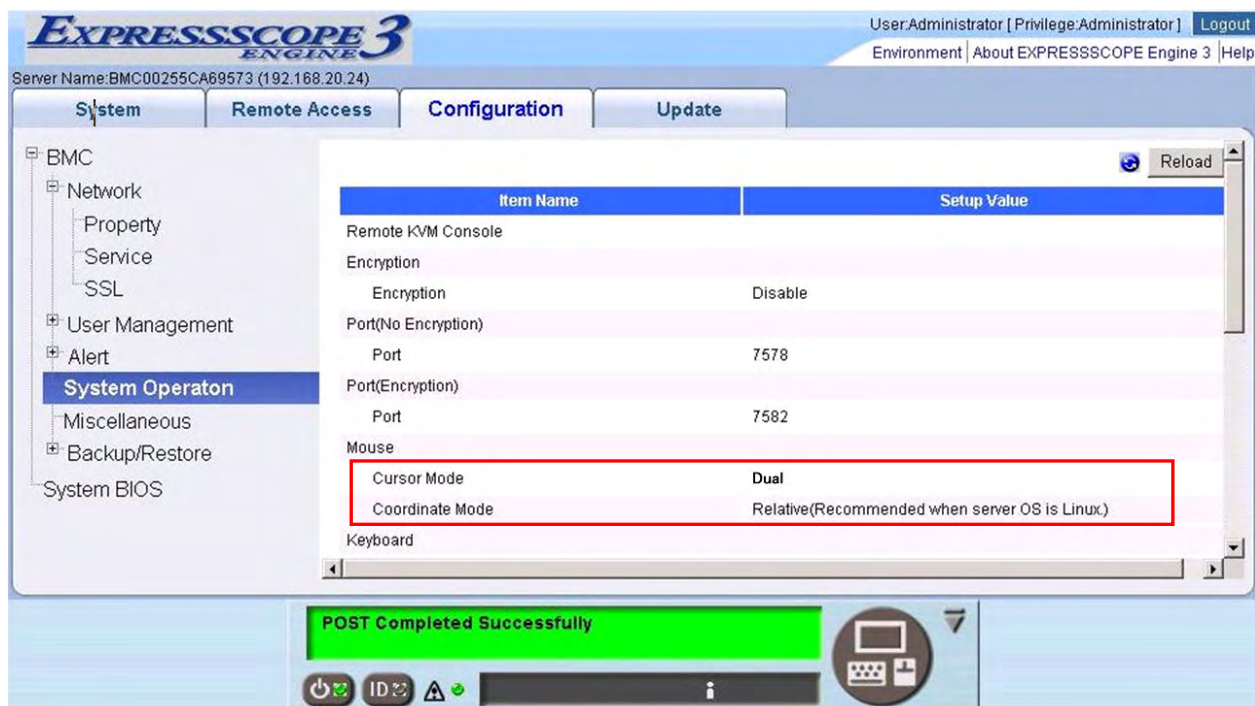
In the case where one of the following disk array controllers is used, the mouse function (mouse pointer displayed on the screen) of the WebBIOS cannot be used when using the Remote KVM of the EXPRESSSCOPE ENGINE 3.

To set up a disk array controller in WebBIOS with the Remote KVM, please select the "Configuration" tab of the EXPRESSSCOPE ENGINE 3 screen, and select "System Operation", and then change "Cursor Mode" to "Dual", and "Coordinate Mode" to "Relative" in "Mouse."

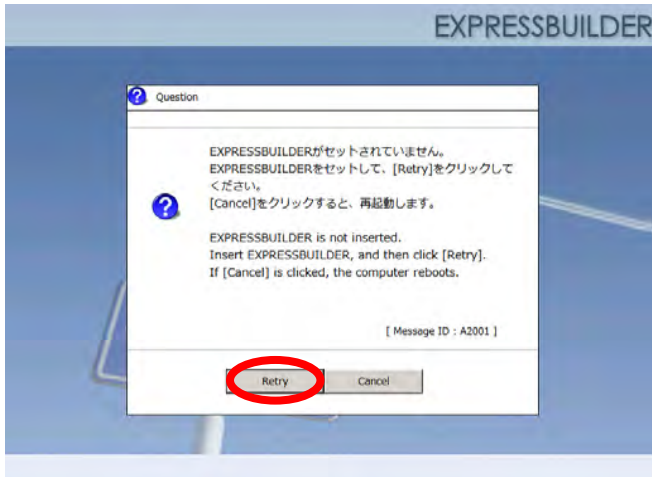
When you start the EXPRESSBUILDER from the DVD-ROM Drive built-in the Blade Enclosure (SIGMABLADE-M, Product code: N8405-016BF) and then select "OS installation", with this product mounted in the Blade Enclosure, the following message may appear.

If the message appears, change the selection of a CPU blade that uses the DVD-ROM Drive built-in the Blade Enclosure from the currently selected CPU blade to another one, and then back to the previously selected CPU blade which is set for the installation source. After that, click "Retry" button to continue the installation.

Loading the EXPRESSBUILDER after changing back to the previous selection may take longer than expected. If the screen does not change after clicking "Retry" button to proceed, please wait for approximately 10 seconds and click "Retry" button again.

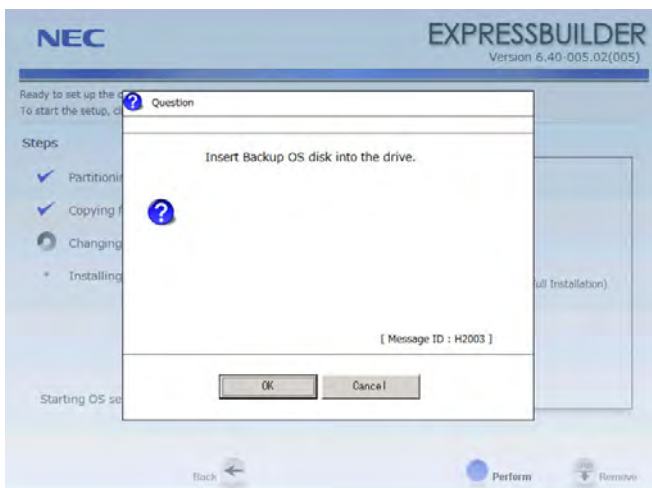
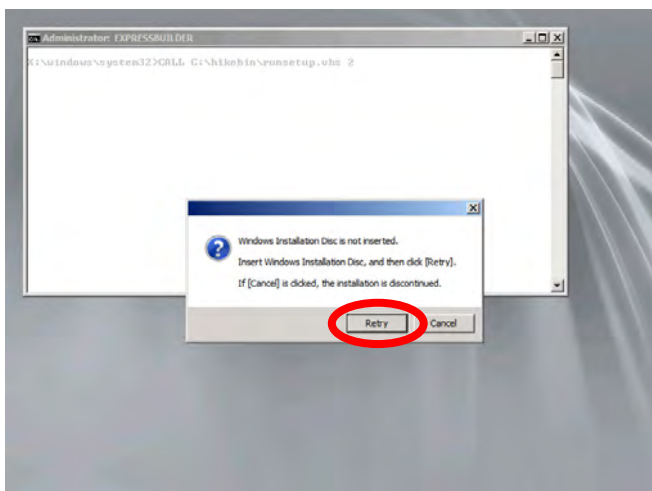
When you set up the OS by using the EXPRESSBUILDER, with Backup OS disk inserted into the drive as instructed in the message below, the message in the next page may appear.

In that case, also, change the selection of a CPU blade that uses the DVD-ROM Drive built-in the Blade Enclosure from the current CPU blade to another one and then back to the previously selected CPU blade which is set for the installation source. After that, click "Retry" button to continue the installation.
