Express5800/D120h

ご使用時の注意事項

Precautions for Using Express5800/D120h

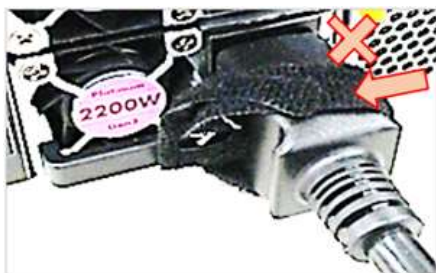
NG例：

ケーブルタイがACケーブルの根元に巻き付けられていない。

Step4. ケーブルタイをACケーブルの根元に上から巻きつける。

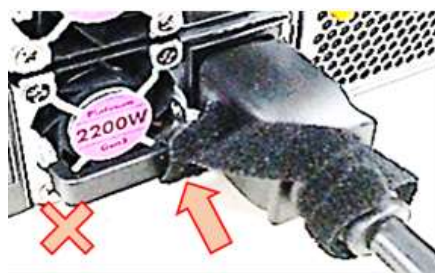
ケーブルタイを電源ユニットのハンドルに巻き付けてない。

Step5. ケーブルタイをハンドルの下から上にハンドルの内側を通す。

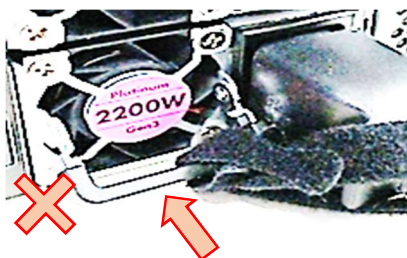
ハンドルが垂直に起きておらず斜めになっているため、ケーブルタイに遊びが出来る。

Step6. ケーブルタイの先端を巻き付けて固定する。
ケーブルタイに遊びが出ないよう電源ユニットのハンドルが垂直の位置になるように注意する。

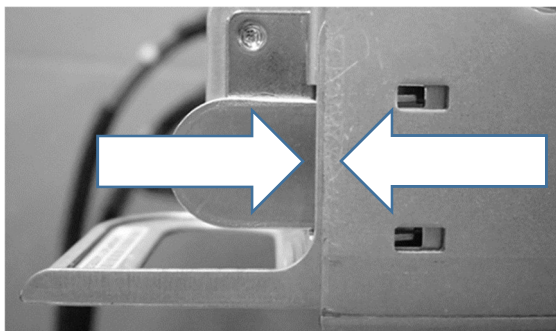
＜ノードが正しく差し込まれていない状態＞

サーバーモジュールをモジュールエンクロージャーに実装する時は以下を注意してください。
奥まで差し込まれていない場合、正しく動作しないことがあります。
「カチッ」とロックがされるまで押し込んでください。

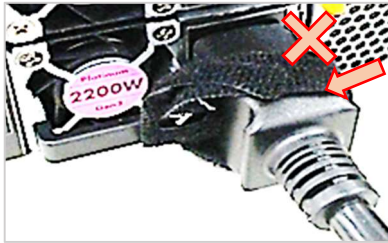
Bad examples :

The cable tie is not wound around the root of the AC cable.

Step4. Wind the cable tie around the root of the AC cable from the top.

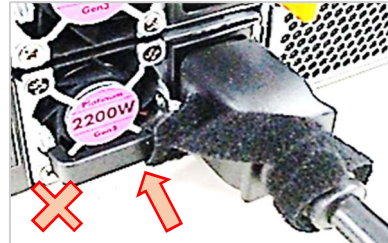
The cable tie is not wound on the handle of the Power Unit.

Step5. Pass the cable tie through the inside of the handle from the bottom of the handle to the top.

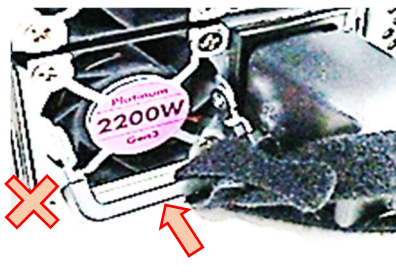
Since the handle is slanted, not positioned vertically, the cable tie is wound loosely.

Confirm that the handle of the Power Unit is positioned vertically and the cable tie is not tied loosely.
