Express5800/R120h-1M, R120h-2M

ご使用時の注意事項

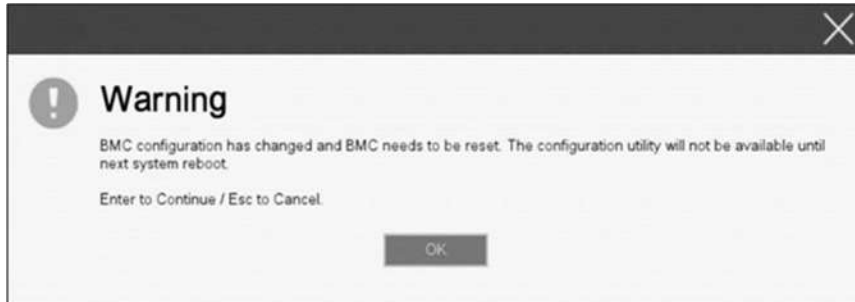
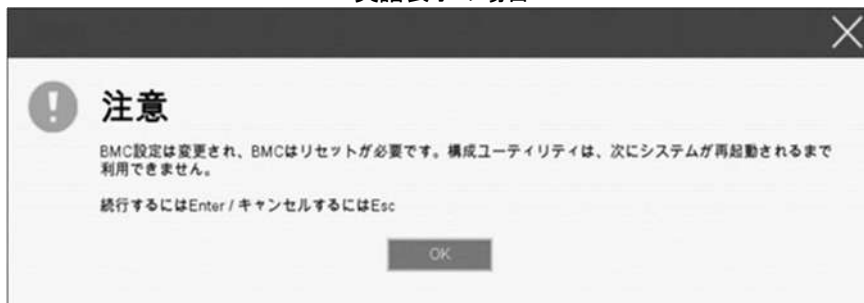
注意事項に従った操作を実施されない場合、「Memory Initialization Start」のメッセージでPOST停止、あるいは、装置に記録されているSerial Number、Product IDの消失が発生する場合があります。

- (1) システムユーティリティの「BMC Configuration Utility」において設定の変更を行うと、iLOの再起動を行うために、次のWarning(注意)ポップアップが表示されることがあります。

- (2) 「OK」を押して進めます。
(3) 次のWarning(注意)ポップアップの表示されます。
このWarning(注意)ポップアップが表示されている状態にて、**必ず1分以上お待ちください。**
その間、何も操作しないでください。

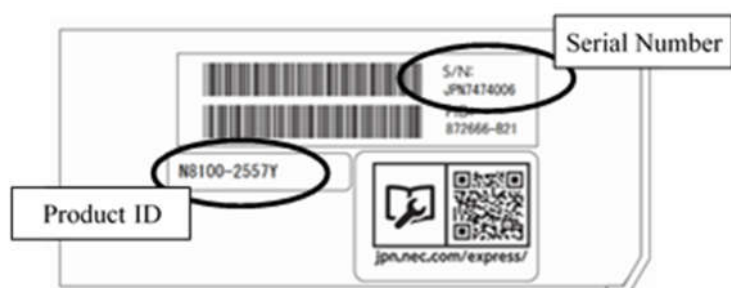
- (13) 装置のスライドタグに記載されているSerial NumberとProduct IDをシステムユーティリティの「System Configuration > BIOS/Platform Configuration (RBSU) > Advanced Options > Advanced Service Options」メニューより、設定します。

【重要】 Product IDとは、『N8100-2557Y』のような型番のことです。

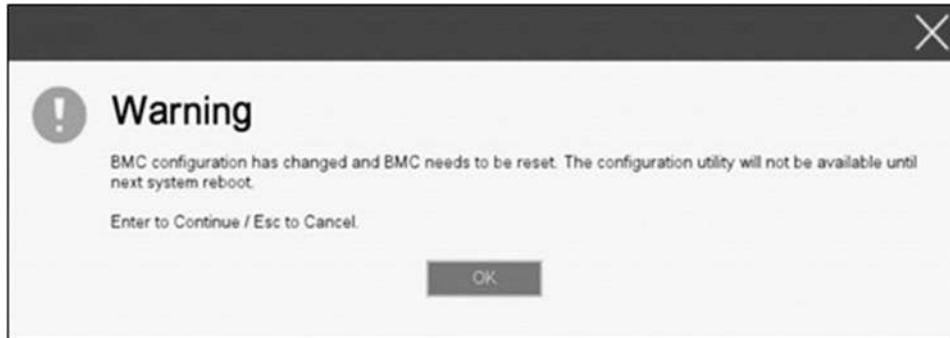
- (1) In the System Utilities, changing the settings of BMC Configuration Utility may display the following pop-up before rebooting the iLO:

- (2) Press OK to proceed.

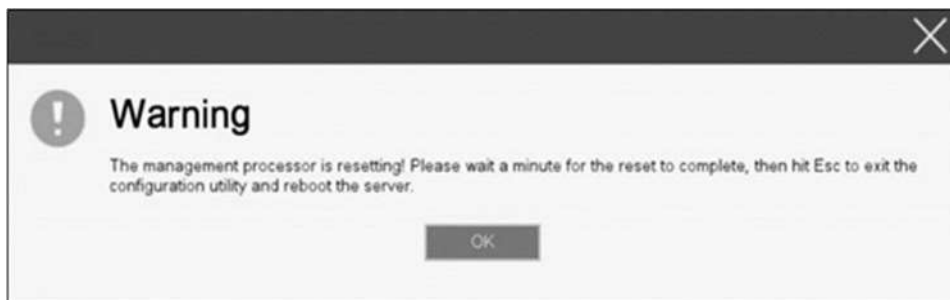
- (3) The iLO will start to reboot and then the following pop-up appears:

- (4) Leave this pop-up at least for one minute.

- (5) Confirm if the iLO reboot is completed.

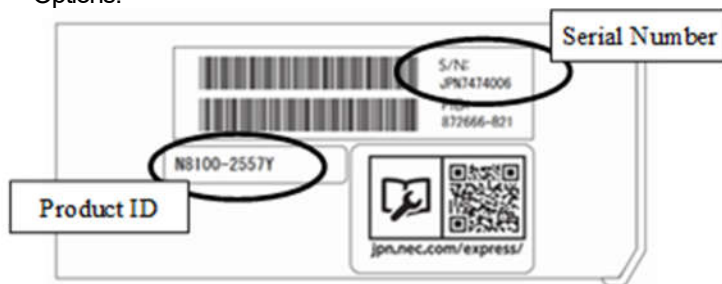
- (12) Press the F9 key to enter the System Utilities.
- (13) Set the proper Serial Number and Product ID (indicated on the pull-out tab of the server) via the menu of the System Utilities: System Configuration > BIOS/Platform Configuration (RBSU) > Advanced Options > Advanced Service Options.

【Important】 Product ID is the model number like "N8100-2557F". Product ID is not PID.
