# Express5800/T120hご使用時の注意事項

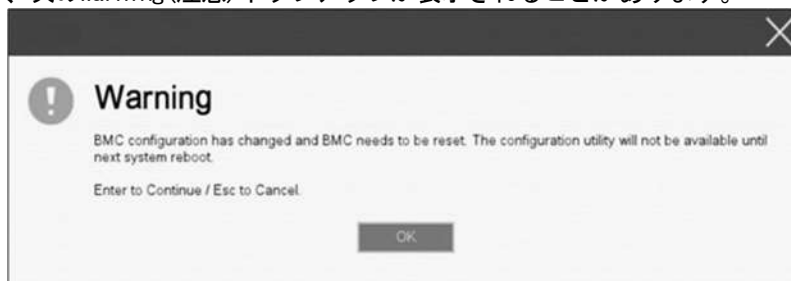
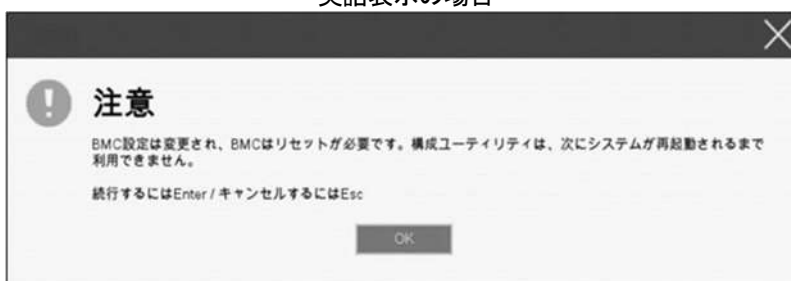
注意事項に従った操作を実施されない場合、「Memory Initialization Start」のメッセージでPOST停止、あるいは装置に記録されているSerial Number、Product IDの消失が発生する場合があります。

- (1) システムユーティリティの「BMC Configuration Utility」において設定の変更を行うと、iLOの再起動を行うために、次のWarning(注意)ポップアップが表示されることがあります。

- (2) 「OK」を押して進めます。  
(3) 次のWarning(注意)ポップアップが表示されます。  
このWarning(注意)ポップアップが表示されている状態にて、**必ず1分以上お待ちください。**  
その間、何も操作しないでください。

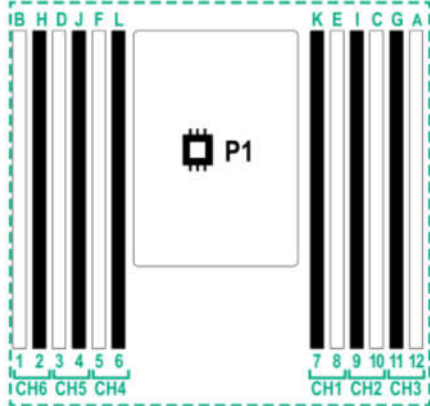
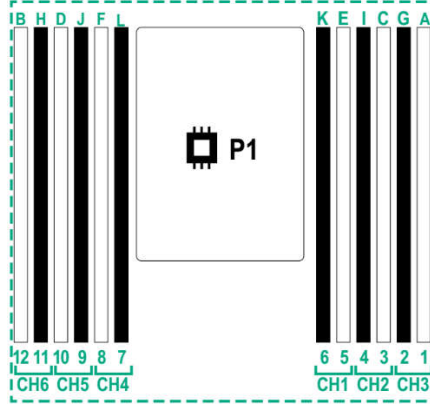
P. 31 5.3 背面	③ ディスプレイポート ディスプレイポートの動作は、N8005-1007 DP-VGA変換コネクタにて確認していますが、お客様で十分検証のうえ、活用ください。	③ ディスプレイポート サポートしていません。
p35 5.5.2 DIMMスロット  P1 DIMMスロット番号

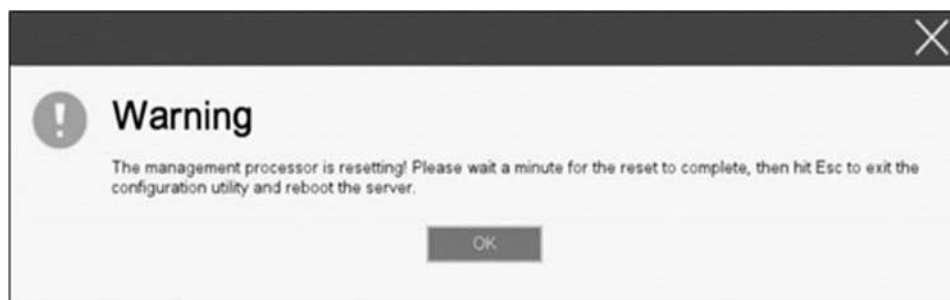
- (3) The iLO will start to reboot and then the following pop-up appears:

- (4) Leave this pop-up at least for one minute.

- (5) Confirm if the iLO reboot is completed.

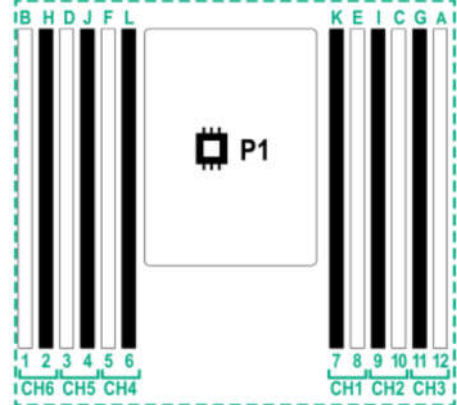
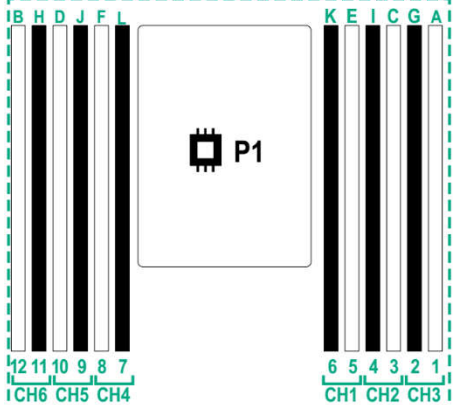
Error	Correct
P.22 3.Features Expandability	Large capacity memory of up to <b>1.5TB</b> *6	Large capacity memory of up to <b>3.0TB</b> *6
P.27 4.3 Rear View (3) DisplayPort	<b>DisplayPort operation is confirmed by the N8005-1007 DP-VGA conversion connector, however, please try to perform a full verification before use.</b>	<b>Not Support</b>
P.31 4.5.2 DIMM slot
