Express5800/T120h ご使用時の注意事項

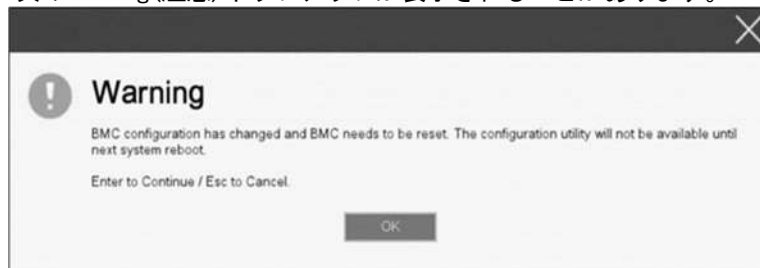
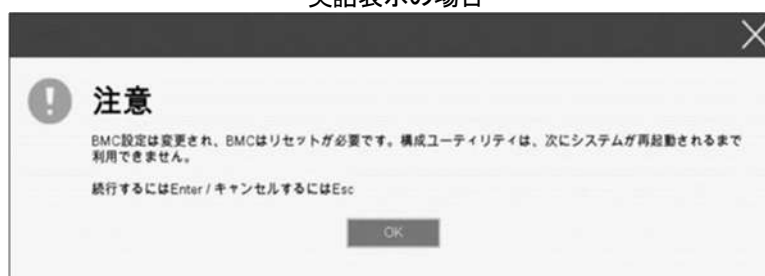
注意事項に従った操作を実施されない場合、「Memory Initialization Start」のメッセージでPOST停止、あるいは装置に記録されているSerial Number、Product IDの消失が発生する場合があります。

- (1) システムユーティリティの「BMC Configuration Utility」において設定の変更を行うと、iL0の再起動を行うために、次のWarning(注意)ポップアップが表示されることがあります。

- (2) 「OK」を押して進めます。

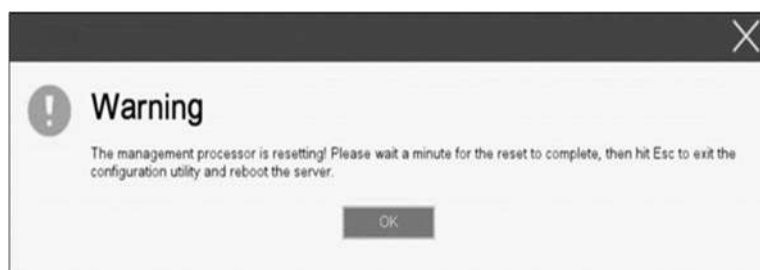
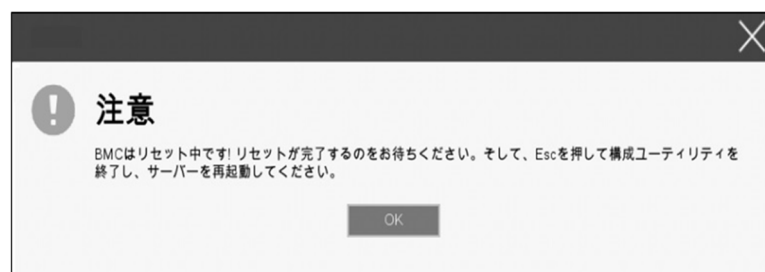
- (3) 次のWarning(注意)ポップアップが表示されます。

このWarning(注意)ポップアップが表示されている状態にて、**必ず1分以上お待ちください。**その間、何も操作しないでください。

- (4) 1分以上経過後、装置前面のステータスランプが緑色で点灯していることを確認してください。

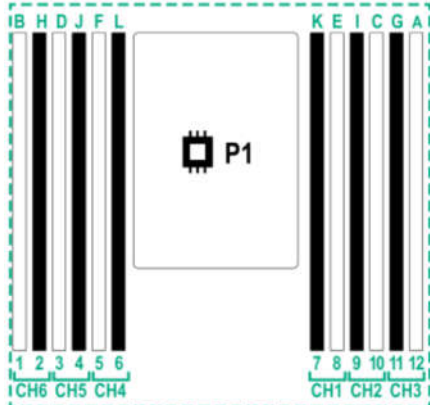
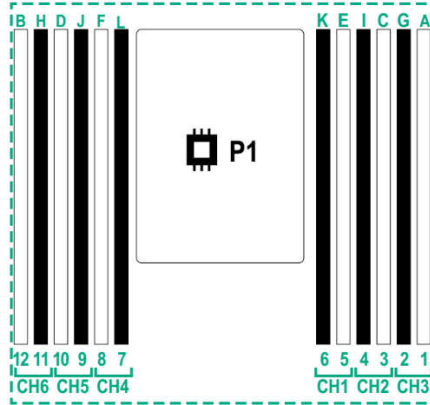
P. 31 5.3 背面	③ ディスプレイポート ディスプレイポートの動作は、N8005-1007 DP-VGA変換コネクタにて確認していますが、お客様で十分検証のうえ、活用ください。	③ ディスプレイポート サポートしていません。
p35 5.5.2 DIMMスロット P1 DIMMスロット番号

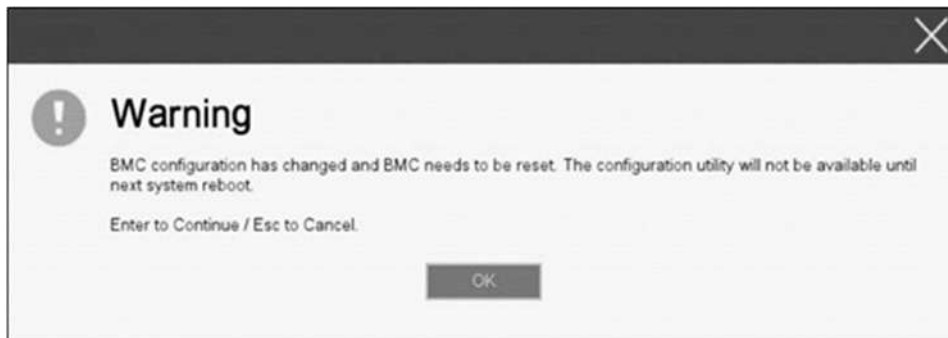
- (1) In the System Utilities, changing the settings of BMC Configuration Utility may display the following pop-up before rebooting the iLO:

- (2) Press OK to proceed.

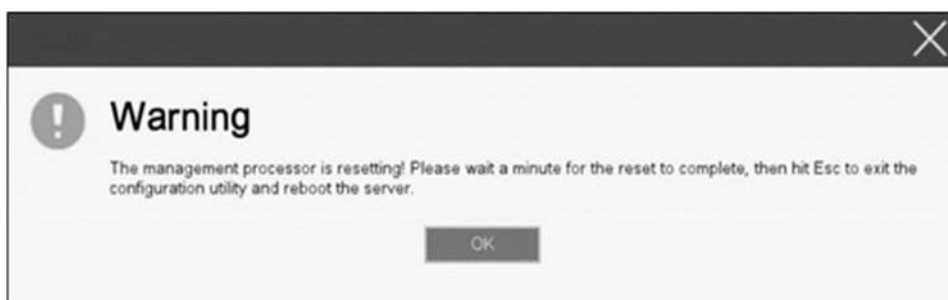
- (3) The iLO will start to reboot and then the following pop-up appears:

- (4) Leave this pop-up at least for one minute.

- (5) Confirm if the iLO reboot is completed.

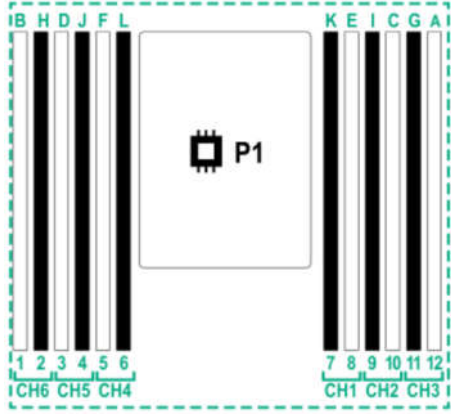
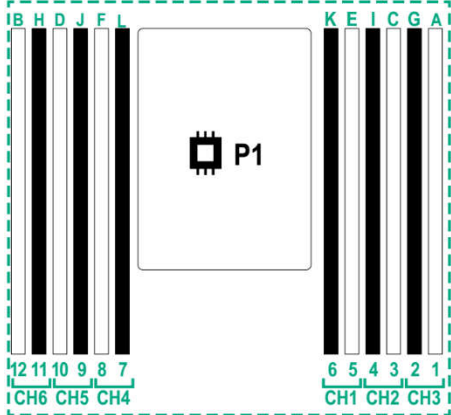
Error	Correct
P.22 3.Features Expandability	Large capacity memory of up to 1.5TB *6	Large capacity memory of up to 3.0TB *6
P.27 4.3 Rear View (3) DisplayPort	DisplayPort operation is confirmed by the N8005-1007 DP-VGA conversion connector, however, please try to perform a full verification before use.	Not Support
P.31 4.5.2 DIMM slot
