# Express5800/T120h ご使用時の注意事項

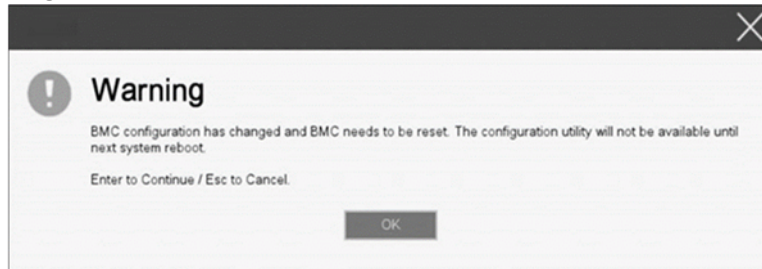
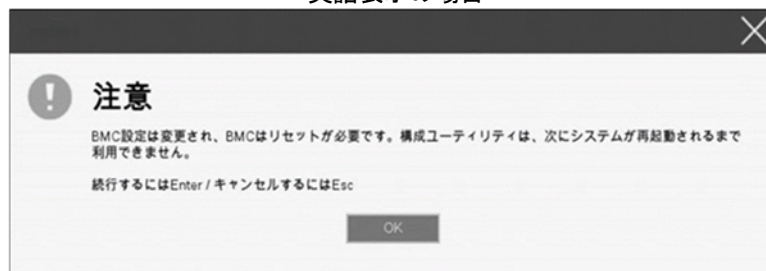
注意事項に従った操作を実施されない場合、「Memory Initialization Start」のメッセージでPOST停止、あるいは、装置に記録されているSerial Number、Product IDの消失が発生する場合があります。

- (1) システムユーティリティの「BMC Configuration Utility」において設定の変更を行うと、iLOの再起動を行うために、次のWarning (注意) ポップアップが表示されることがあります。

- (2) 「OK」を押して進めます。

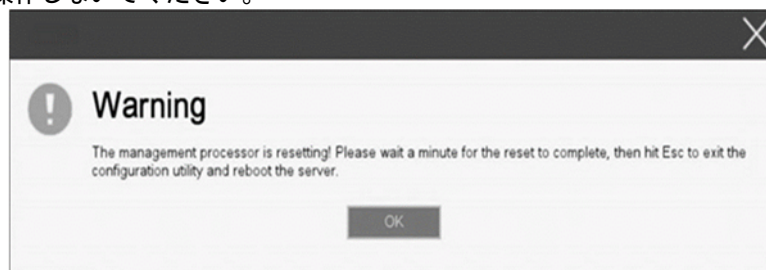
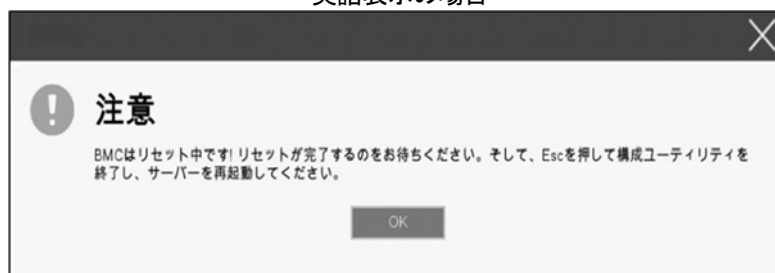
- (3) 次のWarning (注意) ポップアップが表示されます。

このWarning (注意) ポップアップが表示されている状態にて、**必ず1分以上お待ちください。**その間、何も操作しないでください。

- (4) 1分以上経過後、装置前面のステータスランプが緑色で点灯していることを確認してください。

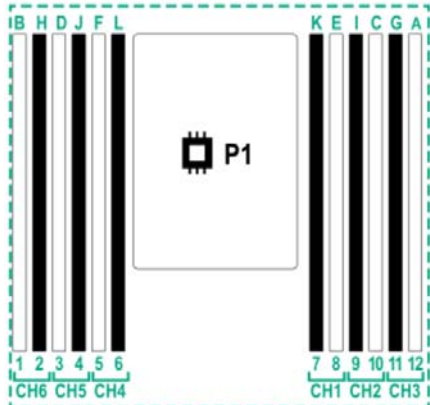
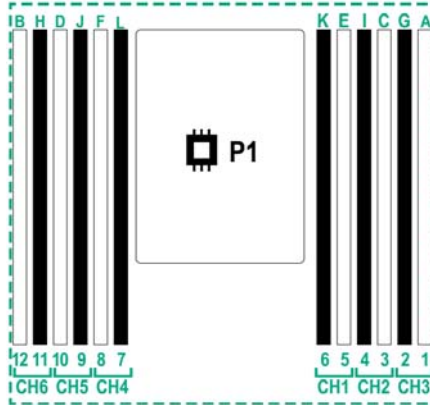
P. 31 5.3 背面	③ ディスプレイポート ディスプレイポートの動作は、N8005-1007 DP-VGA変換コネクタにて確認していますが、お客様で十分検証のうえ、活用ください。	③ ディスプレイポート サポートしていません。
p35 5.5.2 DIMMスロット  P1 DIMMスロット番号

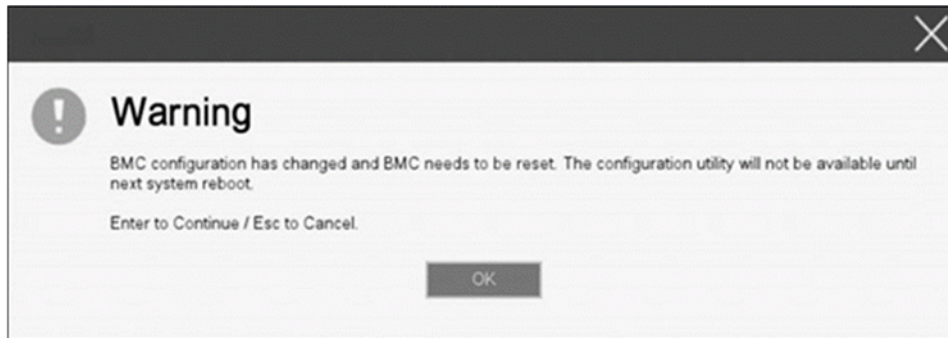
- (1) In the System Utilities, changing the settings of BMC Configuration Utility may display the following pop-up before rebooting the iLO:

- (2) Press OK to proceed.

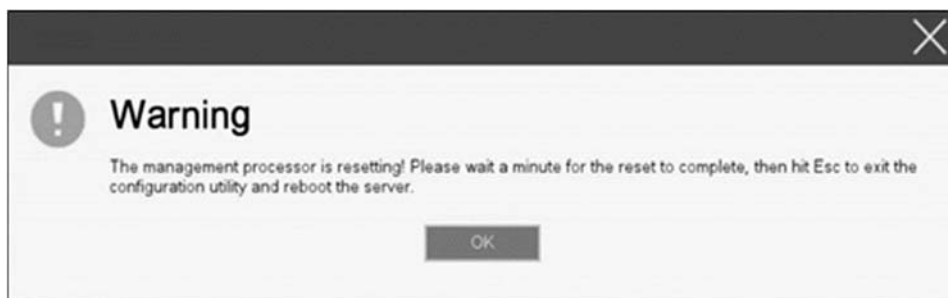
- (3) The iLO will start to reboot and then the following pop-up appears:

- (4) Leave this pop-up at least for one minute.

- (5) Confirm if the iLO reboot is completed.

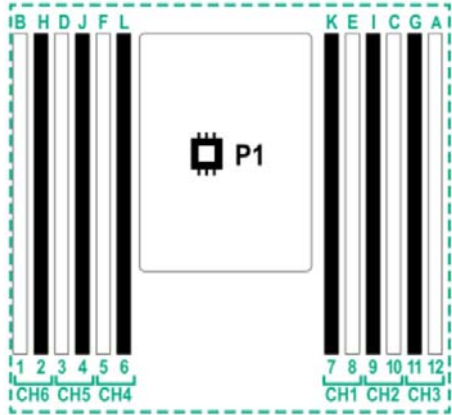
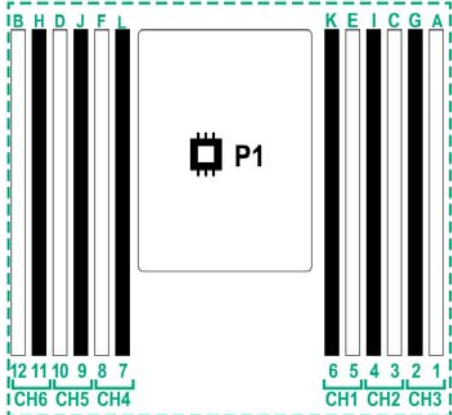
Error	Correct
P.22 3.Features Expandability	Large capacity memory of up to <b>1.5TB</b> *6	Large capacity memory of up to <b>3.0TB</b> *6
P.27 4.3 Rear View (3) DisplayPort	<b>DisplayPort operation is confirmed by the N8005-1007 DP-VGA conversion connector, however, please try to perform a full verification before use.</b>	<b>Not Support</b>
P.31 4.5.2 DIMM slot
